Our Ref: 2023-LF118

PROPERTY ADDRESS

23rd November 2023

RE: PROPERTY ADDRESS – Defect Inspection

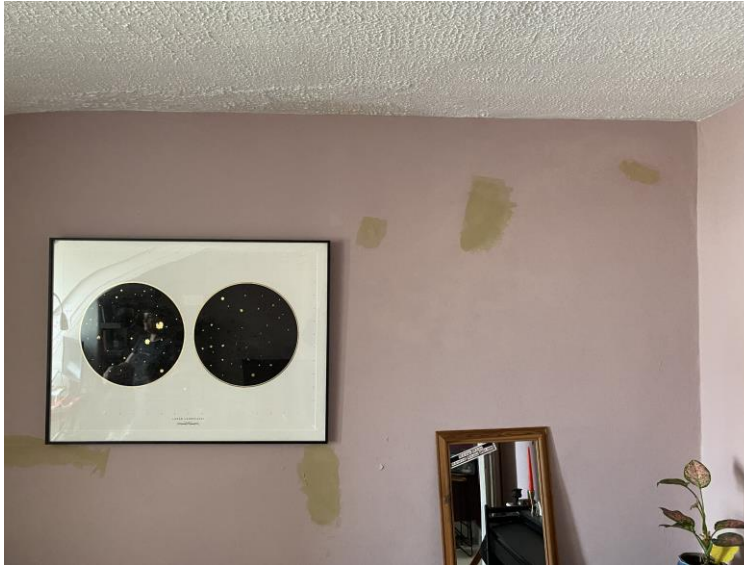
1.

The inspection began in the top floor flat where I was shown three areas of the flat that are suffering from water ingress. Water staining and high moisture readings were recorded to the north wall and adjoining ceiling of the living room. Subpar patch repairs have been carried out on this wall in the past, presumably to address water damaged plaster.

Water damaged and poorly patch repaired north wall to the top floor flat living room.

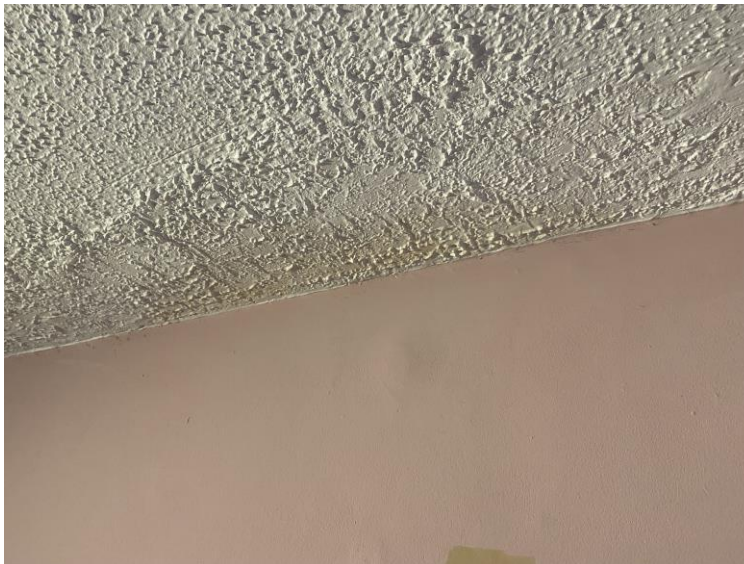
2.

Water stained and saturated ceiling adjacent to the north wall of the top floor flat's living room.

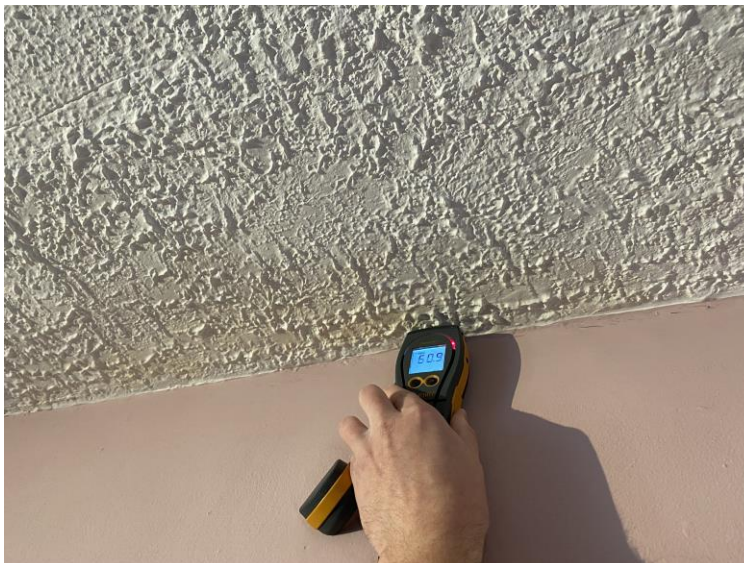
3.

High moisture readings to the ceiling.

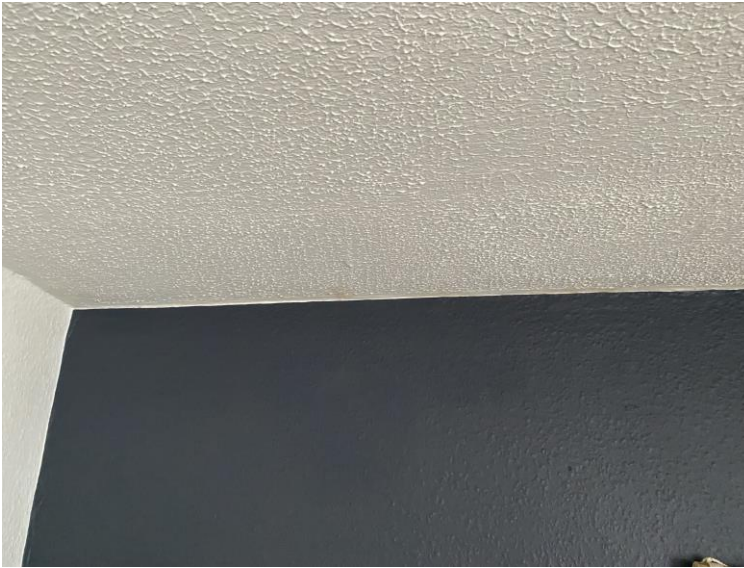
4.

Similar water staining was observed to the ceiling in the rear bedroom where it meets the north wall. High moisture readings were taken from this area, indicating an ongoing water ingress issue.

Water staining to the ceiling adjacent to the north wall of the top floor flats bedroom.

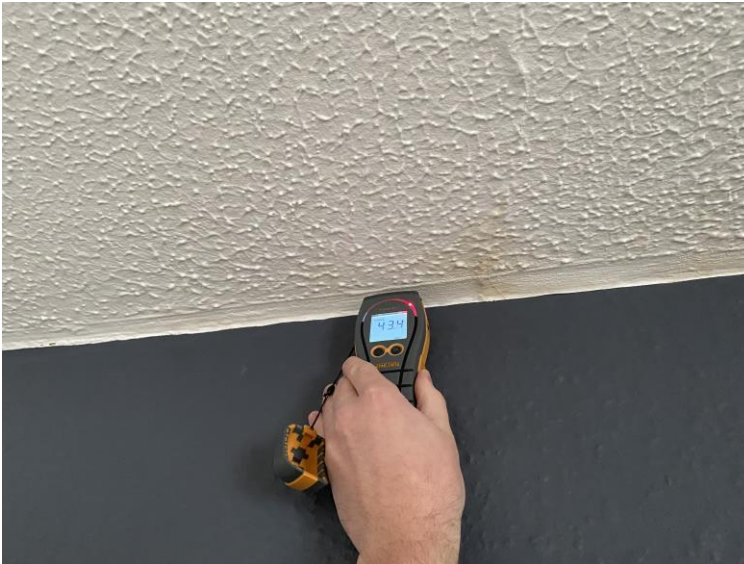
5.

High moisture readings to the ceiling.

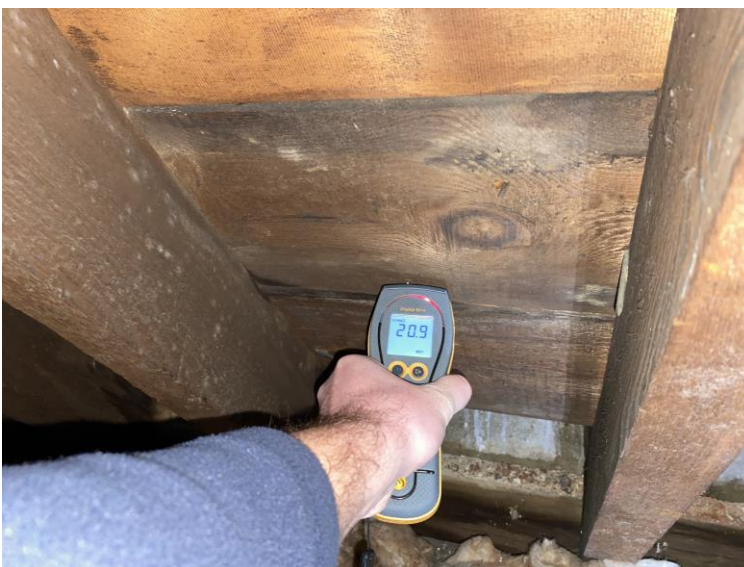
6.

There are no obvious signs of water ingress through the roof structure in the roof space. However, elevated moisture readings and localised mould were recorded to some of the timber rafters and close boarding. This is due to condensation which is caused by inadequate ventilation in the roof space.

Elevated moisture readings and some mould to the timber rafters and close boarding in the roof space above the top floor flat.

- Installation of roof vent tiles to prevent condensation and mould in the roof space.
- Full window redecoration.
- Replacement of the old, corroded front and rear roof windows to the top floor flat - New good quality Velux windows should be considered.
- Redecoration of the external walls, as opposed to localised redecoration where the render is patch repaired. This will ensure a more attractive finish to the building.
- Redecoration of the garden railings.
- Repointing to the rear garden boundary walls.

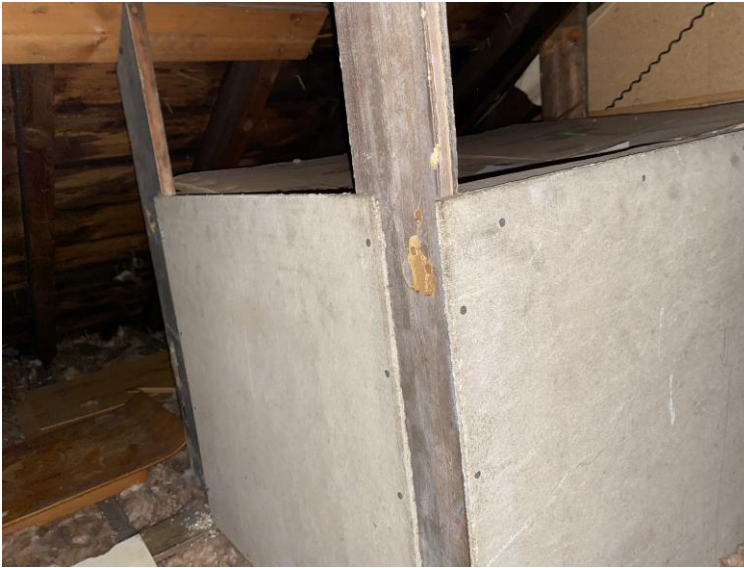
7.

I also noted the presence of fibre cement board which has been used to enclose the cold-water tank. This material is potentially asbestos containing and therefore care must be taken not to disturb it. This material is currently in a sound condition.

Presumed asbestos fibre cement board to the cold-water tank in the roof space.

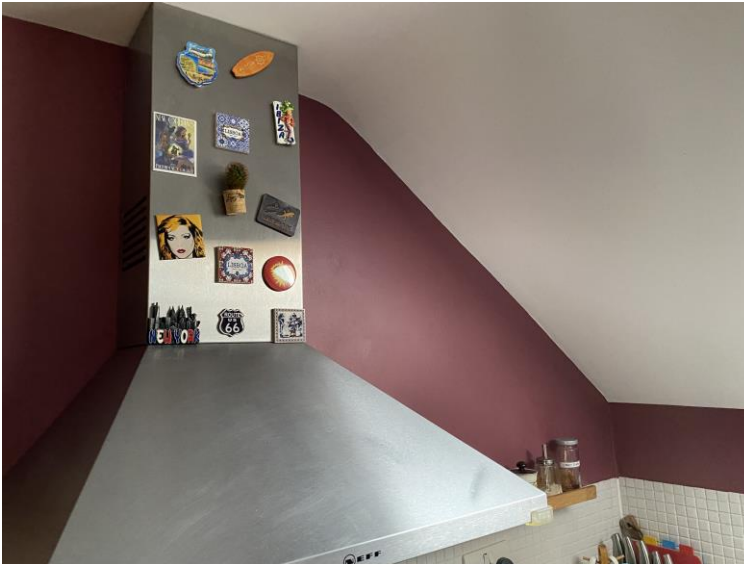
8.

In the kitchen, elevated moisture readings were taken from the south wall.

South wall of the top floor flats kitchen affected by water ingress.

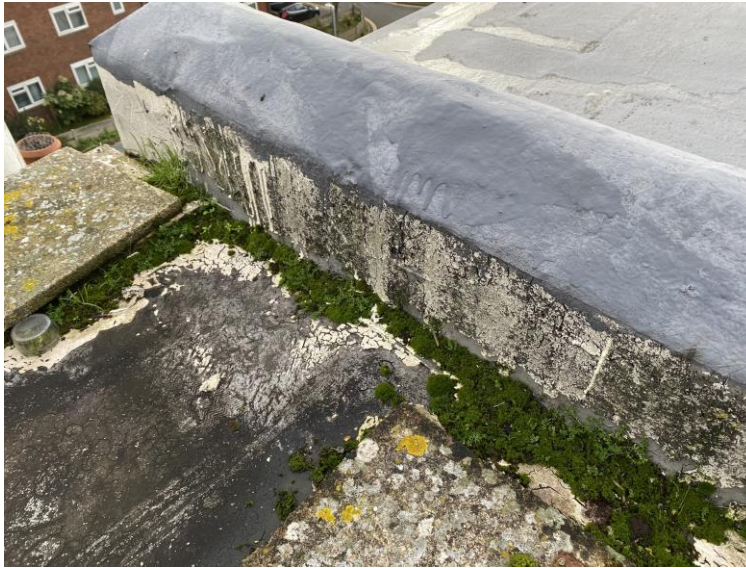
10.

Render to all roof party walls is badly cracked and deteriorated, particularly at low-level where it has been applied over the lead flashings. Render should not be used in contact with lead, as the thermal movement of lead can cause premature failure of the render. The compromised state of these roof party walls has contributed to water ingress into the top floor flat.

Cracking to the rendered party wall on the south side of the four-storey projection roof.

- Re-rendering of all roof party walls and re-using the lead flashings. New render is to be taken down to a bell-drip detail tightly fitted above the lead flashings.

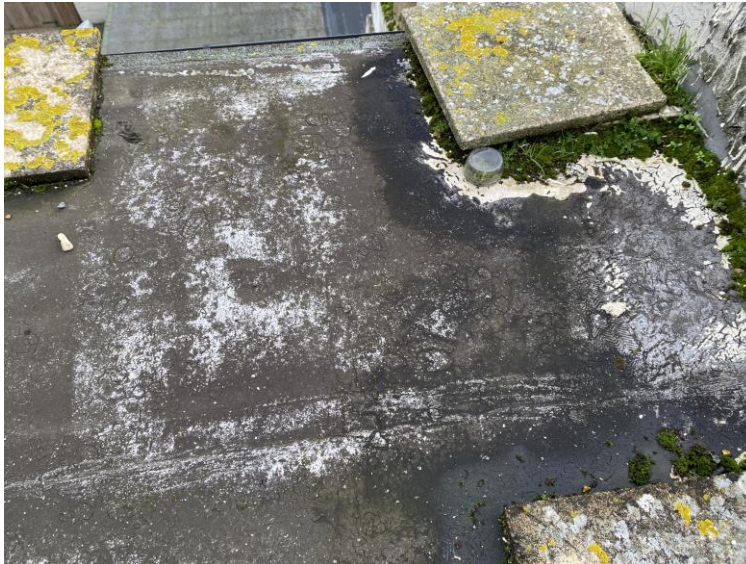
11.

The rear dormer and both rear projections have mineral felt coverings. All three felt coverings have exceeded their serviceable life as evidenced by widespread deterioration and splits. These are at risk of water ingress.

Heavily worn felt over the four-storey projection roof.

- Replacement of rotten timber to the dormer windows and replacement of the lead cover flashing to the front dormer.
- Re-covering of the three flat roofs with new three-layer high performance mineral felt coverings. New insulation will be included in the flat roof coverings to meet current U-Values specified under Part L of the Building Regulations.

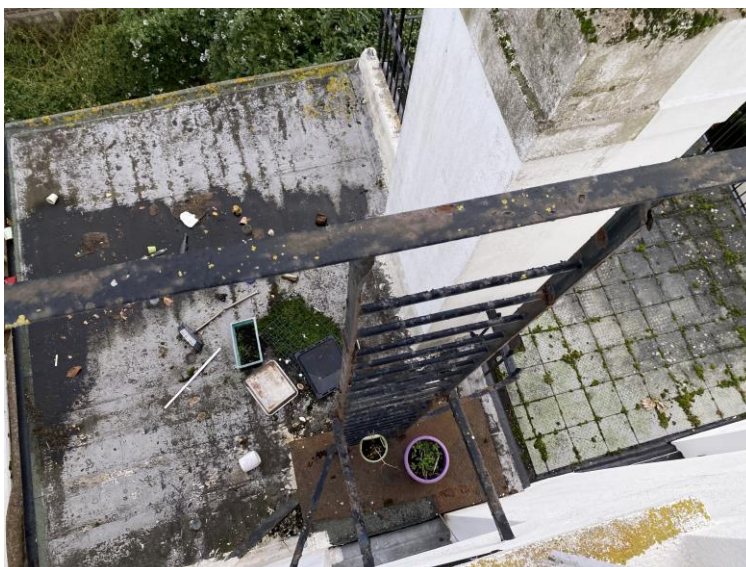
12.

There is a cast-iron fire escape ladder fixed to the rear wall of the four-storey projection and this extends to the roof over the two-storey projection. The ladder is suffering from widespread paint delamination and advanced corrosion of the metal.

Advanced corrosion to the rear roof fire escape ladder.

- Treatment and redecoration of the metal fire escape ladder using proprietary metal coatings.
- Unblocking of all rainwater gutters and repairing any damaged sections and seals.

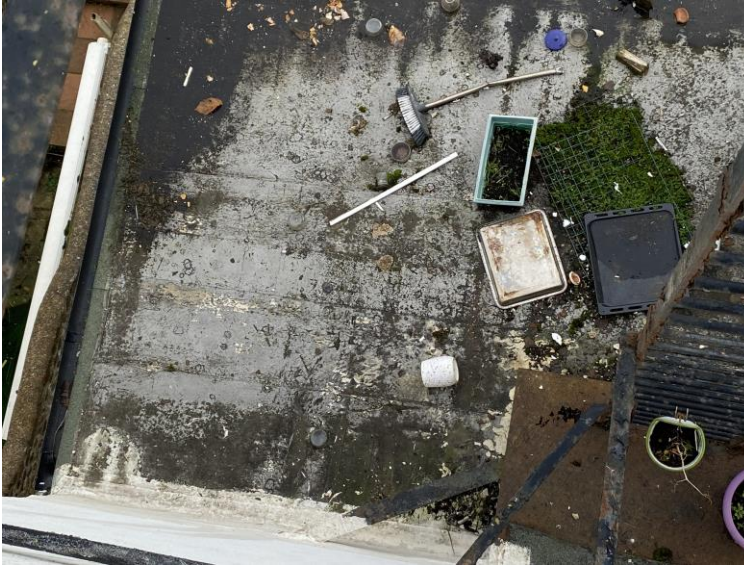
13.

Heavily worn felt covering over the two-storey projection flat roof.

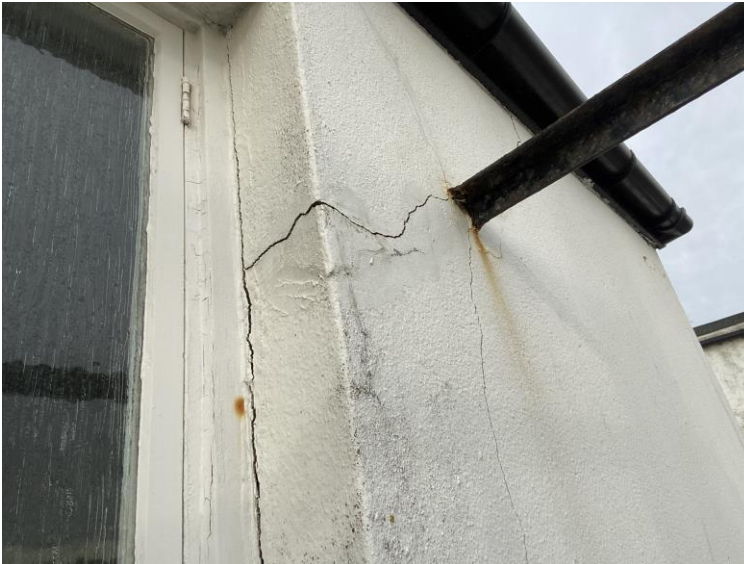
14.

On the rear wall of the rear four-storey projection, there are some large cracks in the render and masonry substrate. This is due to corrosion of the cast-iron fire escape ladder where it is embedded in the wall. Due to corrosion, the metal has expanded which has caused the cracking.

Cracked render and masonry to the rear of the four-storey projection.

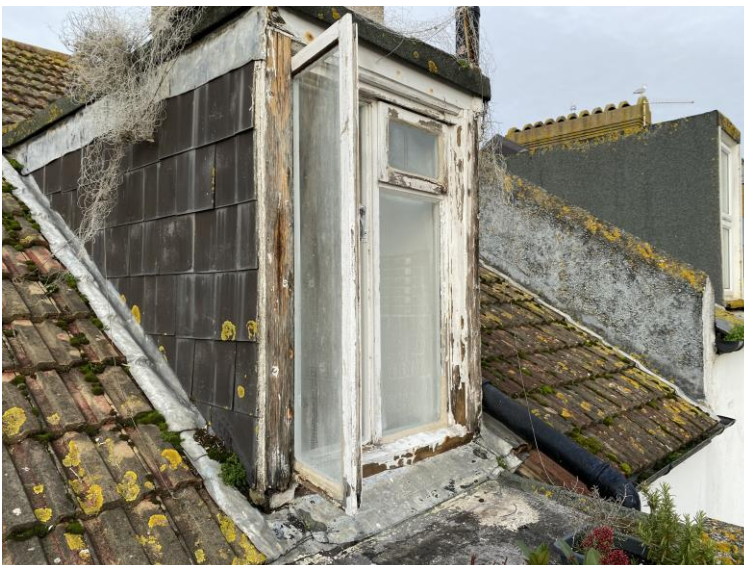
15.

Dormer cheeks have slate hung cladding and this is in a satisfactory condition. Timber window casings to the face of both dormers are suffering from wet rot decay.

Rotten timber to the rear dormer.

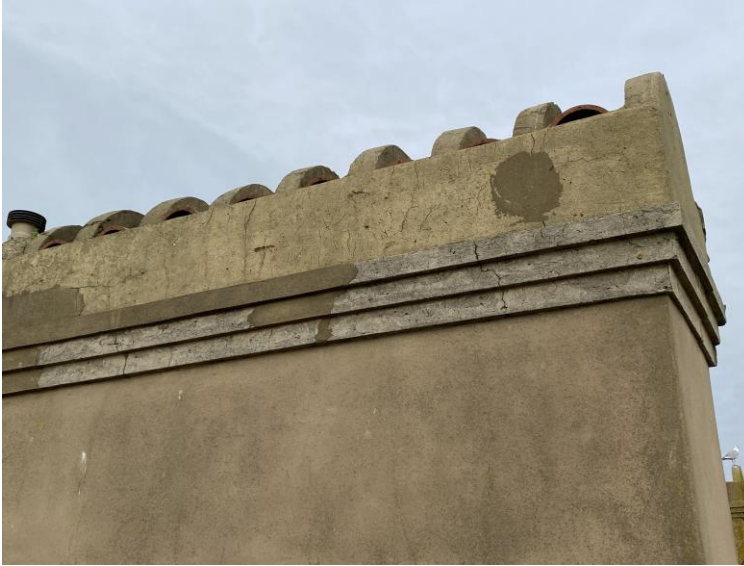
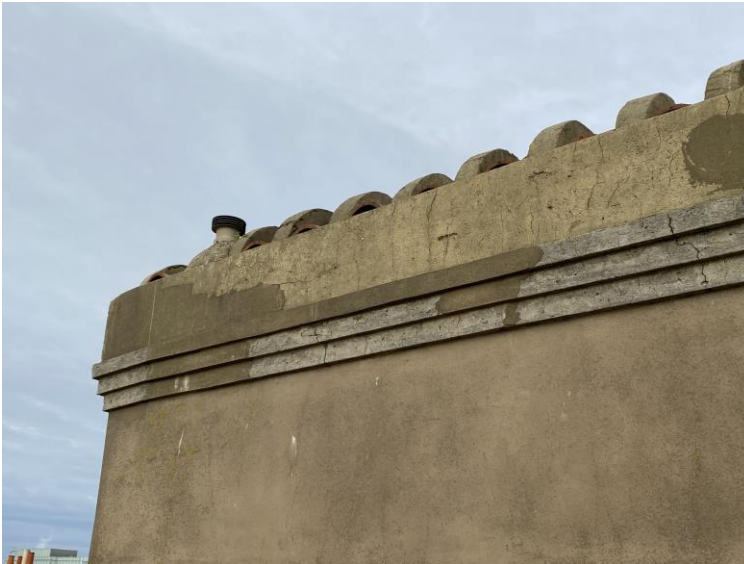
Much of the render to the large party chimney stack appears to have been replaced in recent years, however, cracking is visible to the high and low-level render of the stack.

Cracked render to the top of the chimney stack.

- Cracked render to the chimney stack should be hacked off and replaced.
- The valley gutter between the chimney and north roof pitch should be re-lined using good quality lead.

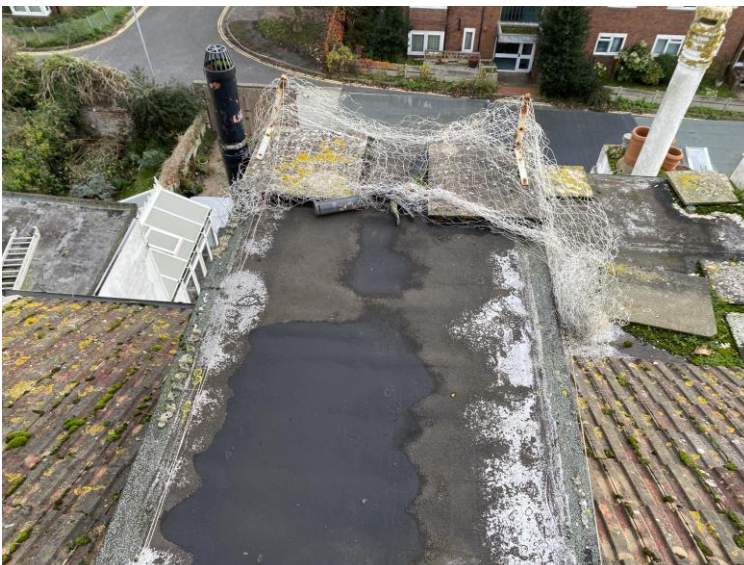
18.

Heavily worn felt over the rear dormer flat roof.

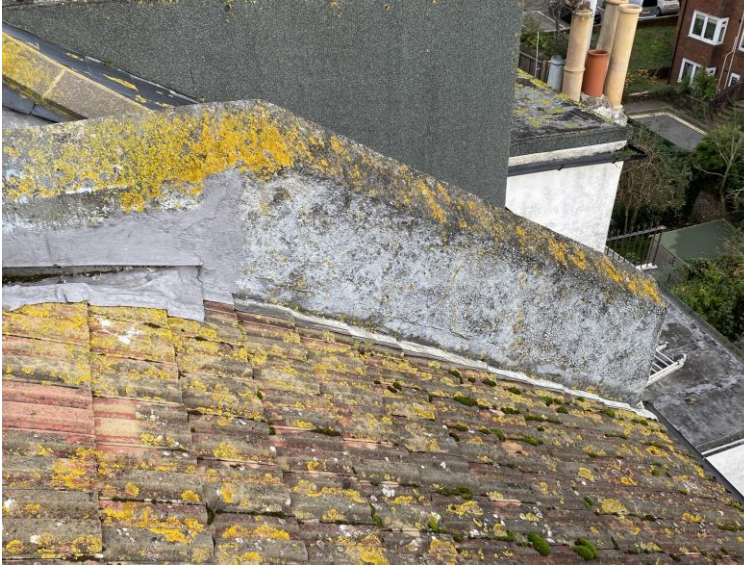
19.

Cracked render to the rear north roof party wall.

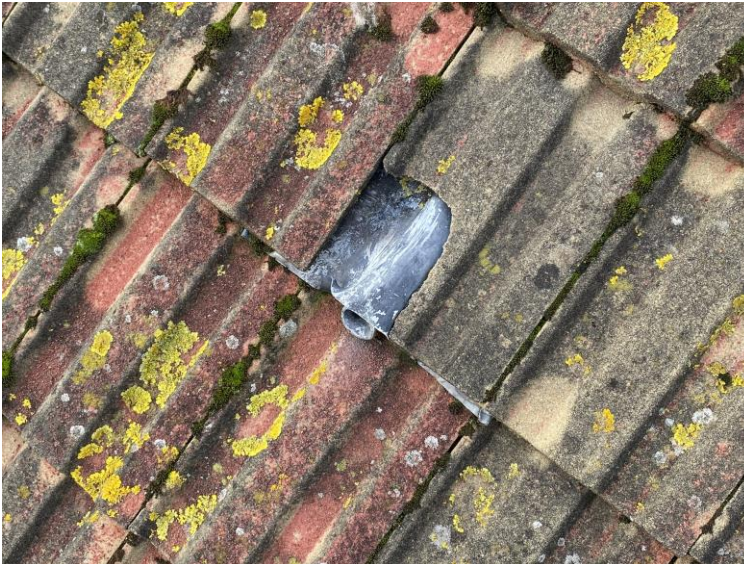
20.

sarking felt underlay below the roof tiles ensures a secondary line of defence against moisture ingress. I did, however, note one broken tile which appears to have been broken to allow for the installation of an overflow for the roof space cold water tank. A smaller notch could have been made in this tile for the overflow pipe, and there is a risk that the current broken tile could permit water ingress.

Broken roof tile to the rear pitch and cold-water tank overflow pipe.

- Re-bedding of the ridge and hip tiles to the roof.
- Replacement of the broken tile over the water tank outlet.
- Re-configuration of the valleys either side of the front dormer roof. The 2006 NHBC standards recommend a minimum valley width of 125mm.

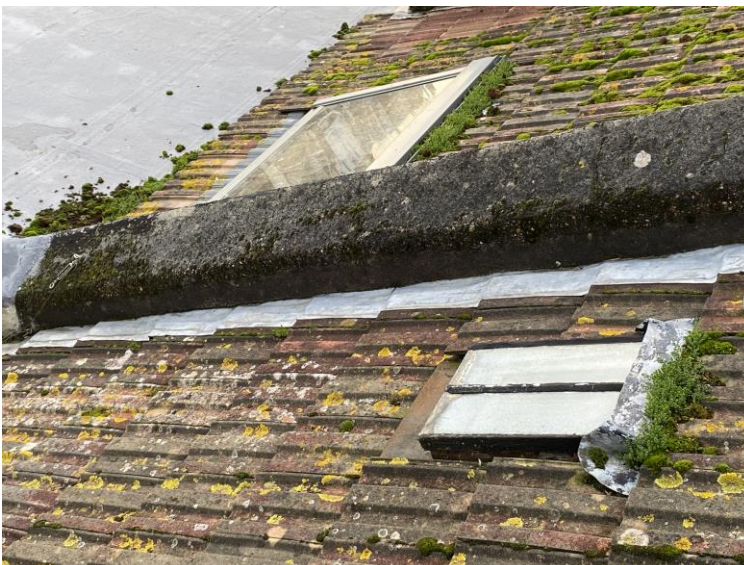
21.

Cracked render to the rear south roof party wall.

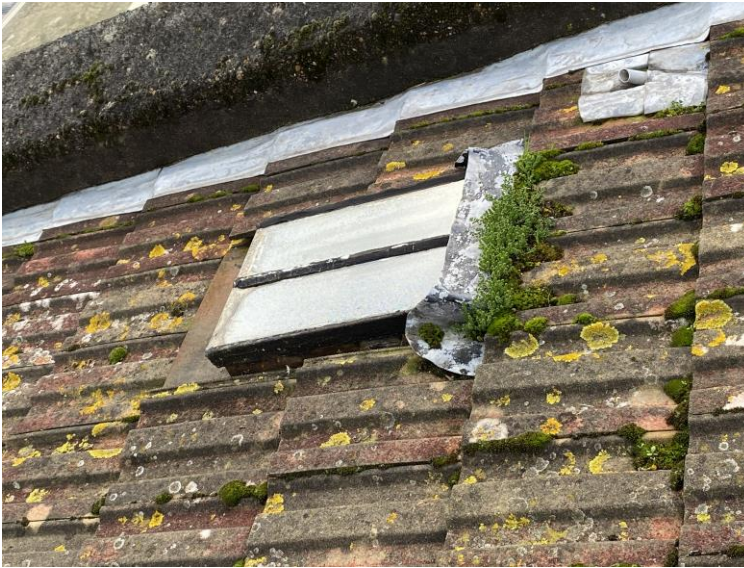
22.

There are two old, metal roof windows to the front and rear roof pitches. Metal parts to these windows are suffering from corrosion, and the timber parts are suffering from wet rot decay. In addition, the perimeter gutter channels are heavily blocked with vegetation.

Corroded and rotten frame to the rear roof light with vegetation blocking the perimeter gutter channels and flashings.

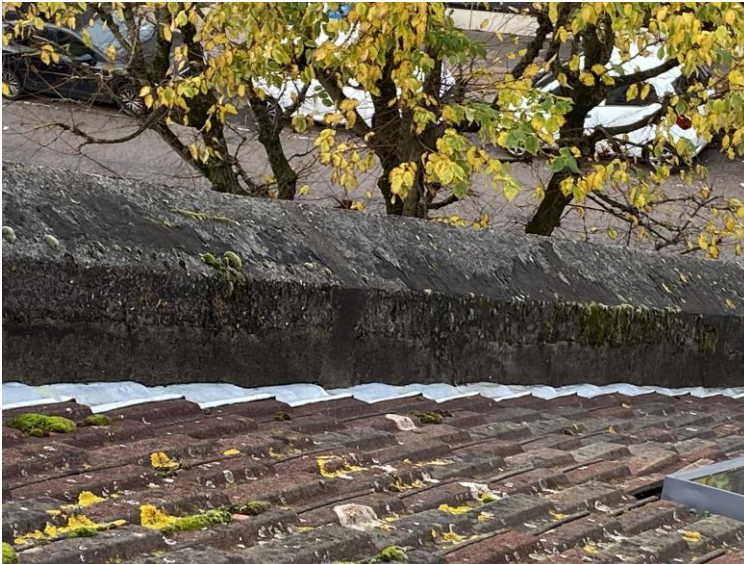
23.

Cracked render to the front south roof party wall.

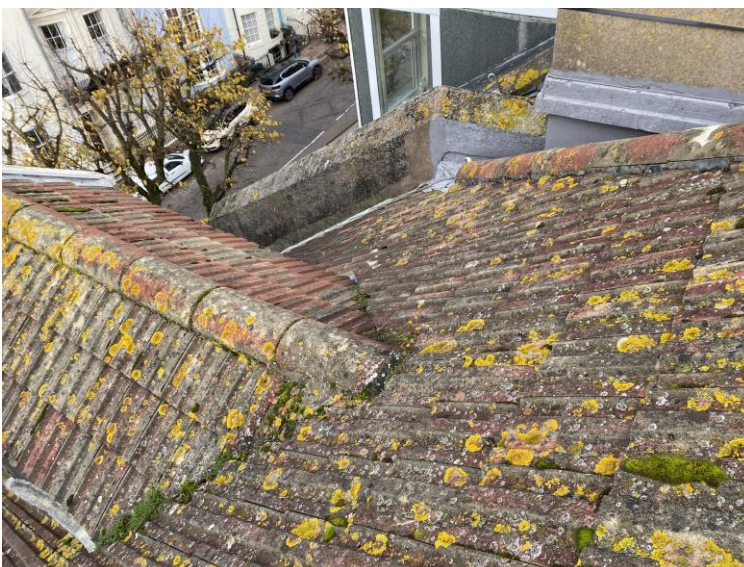
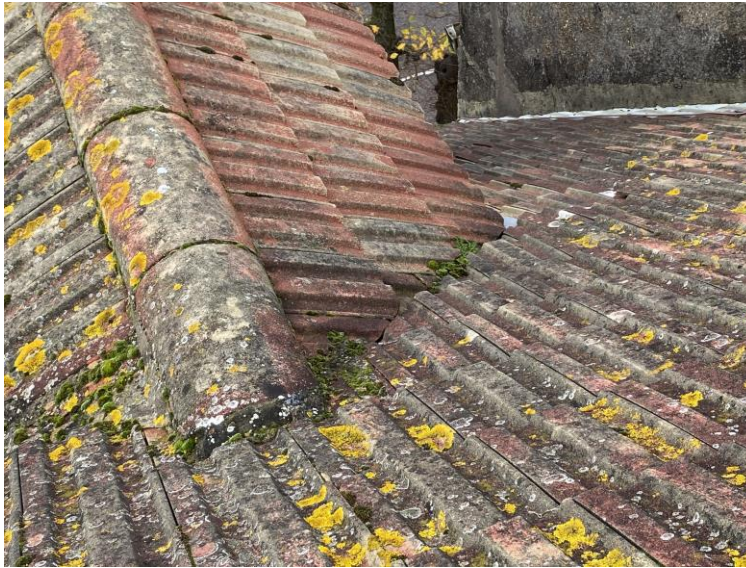
There are poorly designed narrow valleys either side of the front dormer roof, where it meets the front roof pitch. This creates a risk of blockages which can lead to water ingress, and indeed these valleys are blocked with vegetation. No signs of water ingress are apparent below these valleys at this moment in time.

Poor quality valleys either side of the front dormer gable roof where it meets the front roof pitch.

Poor quality narrow roof valleys either side of the front dormer.

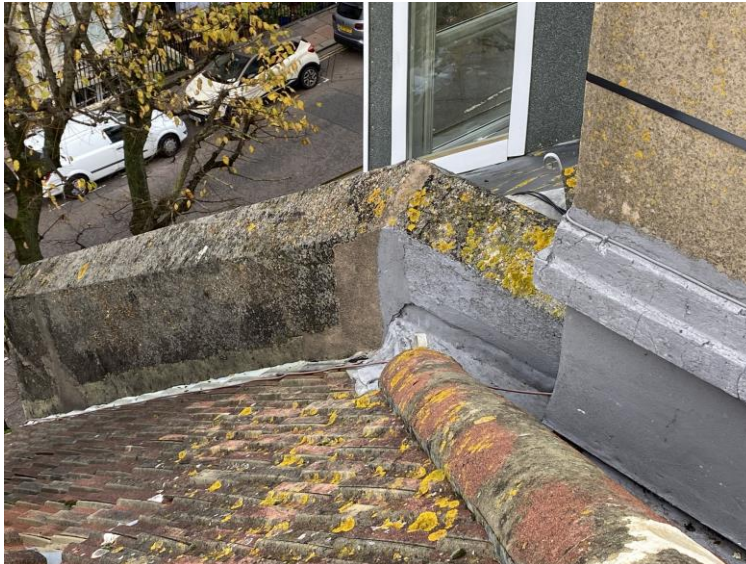
26.

Cracked render to the front north roof party wall.

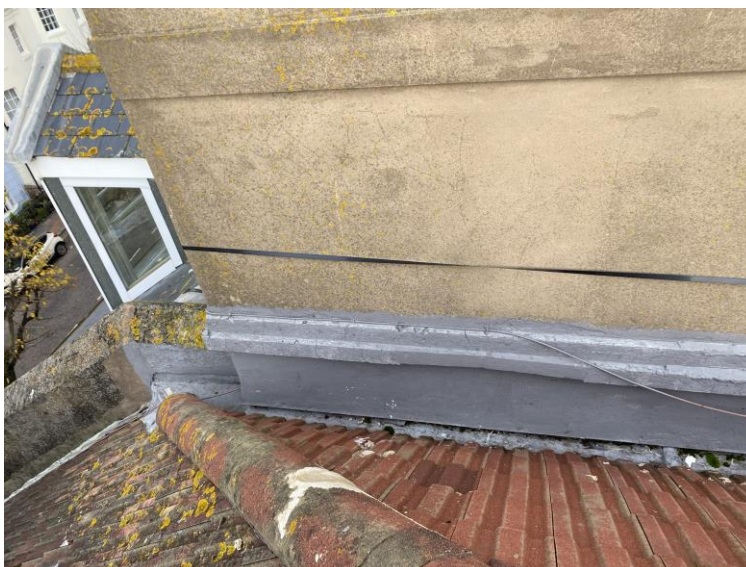
27.

Between the chimney stack and north roof pitch, there is a valley gutter. This is believed to be the primary cause of water ingress into the top floor flat. Basic attempts to prolong the life of the lining using a liquid system have been carried out, and this has clearly failed to prevent water ingress into the flat.

Valley between north pitch and the chimney stack, believed to be leaking into the top floor flat. Attempts have been made to prolong the life of this valley by coating it with a liquid system.

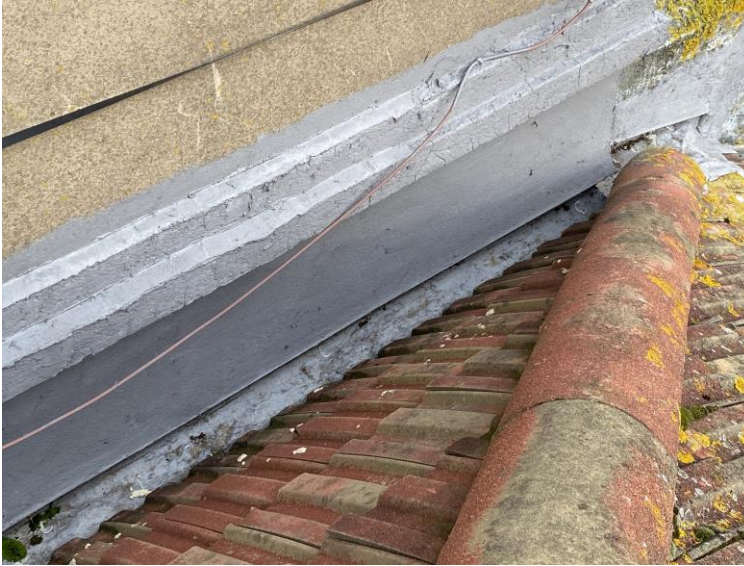
28.

Worn valley lining.

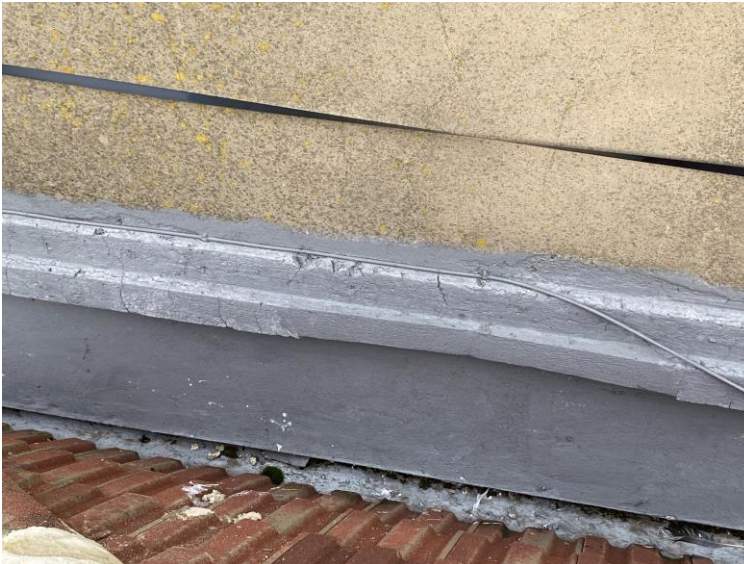
29.

Cracked low level render to the chimney stack coated with a liquid system.

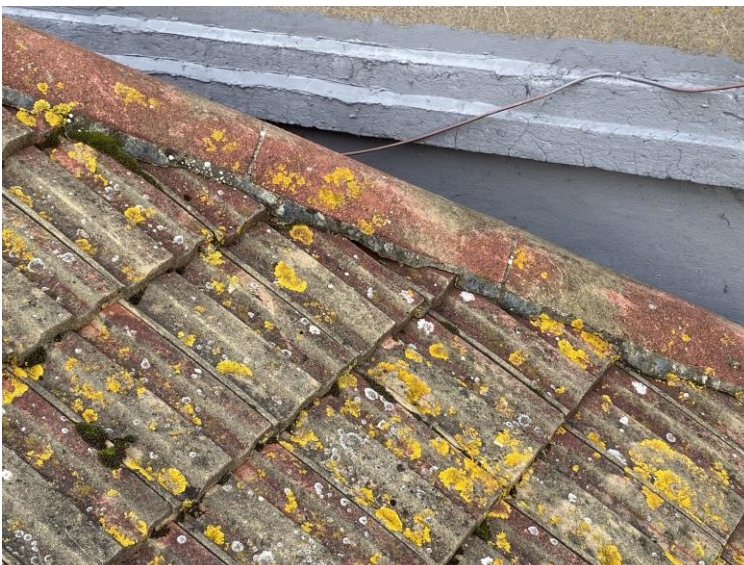
30.

Mortar bedding to multiple ridge and hip tiles has cracked and deteriorated. This creates a risk of ridge and hip tiles dislodging from the roof in high winds.

Deteriorated mortar bedding to the roof hip and ridge tiles.

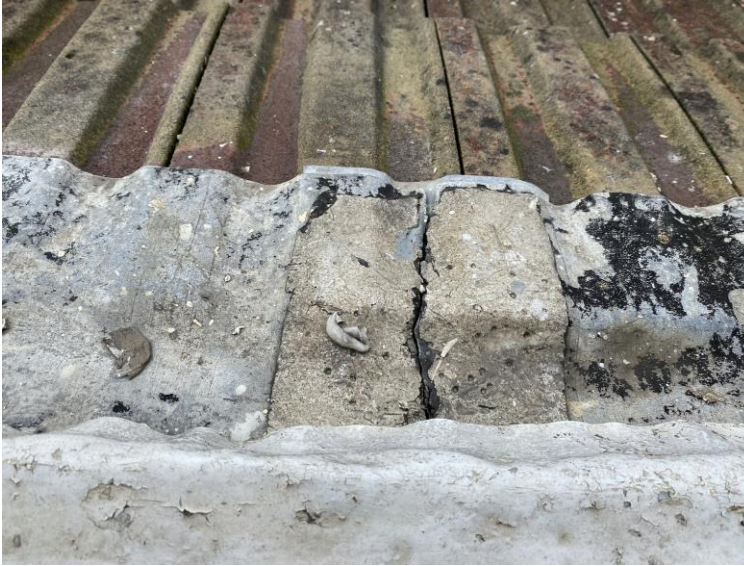
31.

Lead flashings either side of the dormers are also in satisfactory condition. However, the lead cover flashing to the front of the front dormer has split.

Split lead cover flashing to the front dormer.

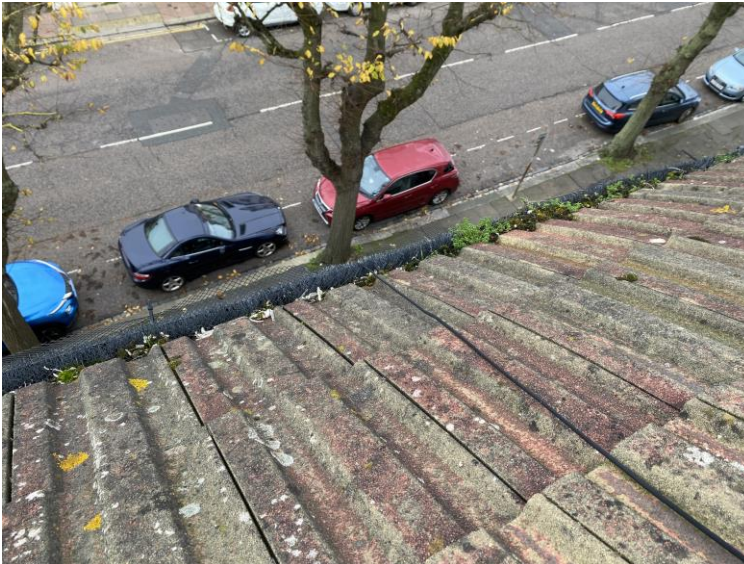
32.

uPVC gutters to the front and rear of the roof are heavily blocked with vegetation and are overflowing.

Heavily blocked front gutters.

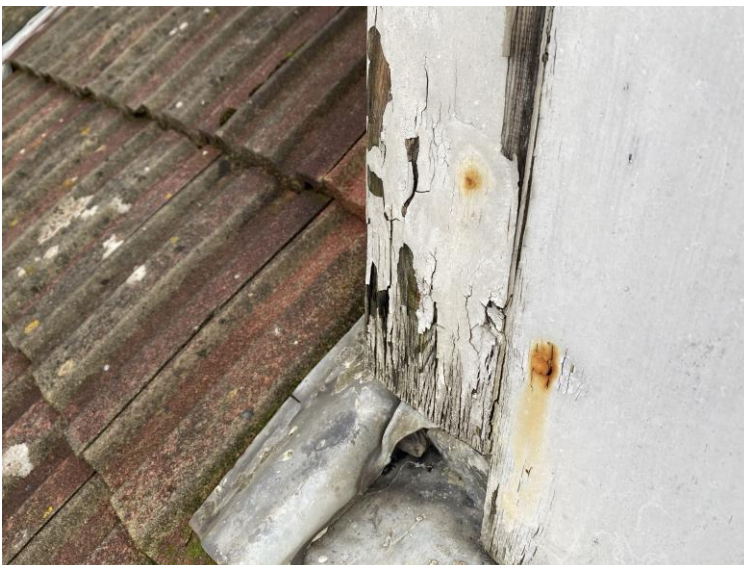
33.

The sliding timber sash window to the front dormer and rear timber casement window to the rear dormer are suffering from wet rot decay.

Rotten timber to the front dormer window.

- Replacement of rotten timber and redecoration to the dormer windows.
- Redecoration of the bay window railings and balcony railings and repairs to the damaged balcony spindles.

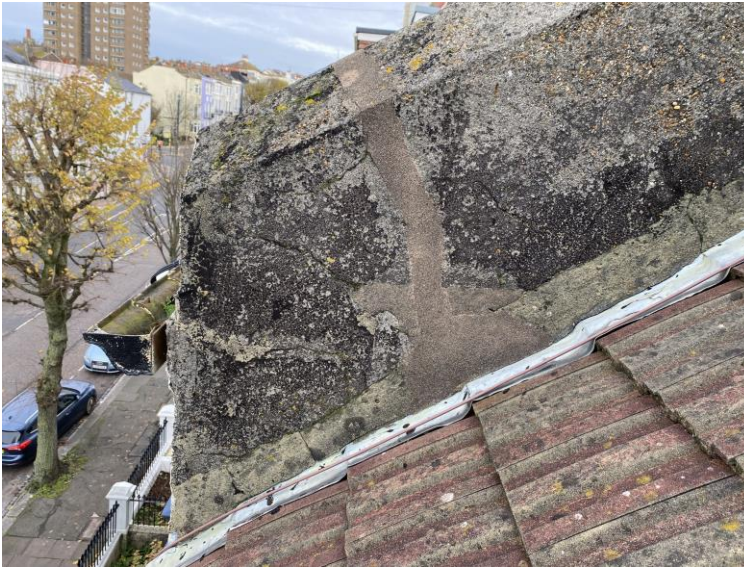
34.

Cracked render to the front north roof party wall.

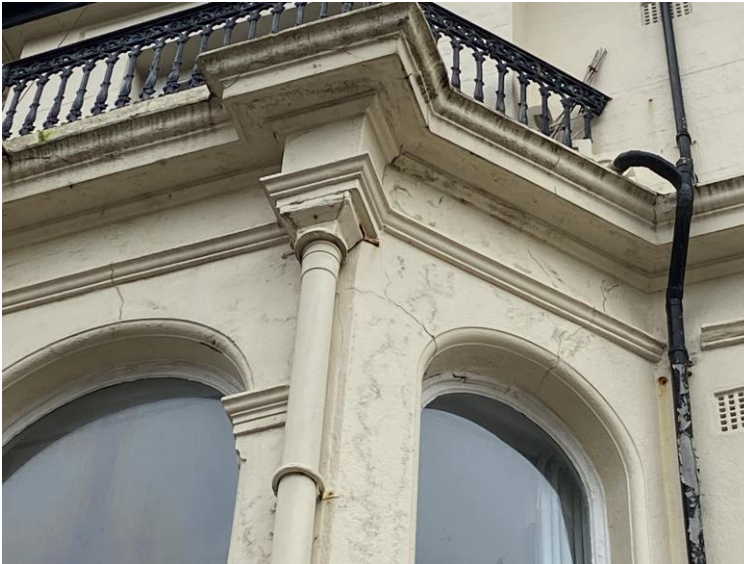
35.

Render to the front and rear elevations is cracked in large areas. Rendered cornices are also cracked throughout with some localised vegetation growth.

Cracked render to the front elevation bay window.

- Replacement of cracked render to external walls and reforming cracked cornices. Includes for localised redecoration to the render patch repairs and removal of vegetation.

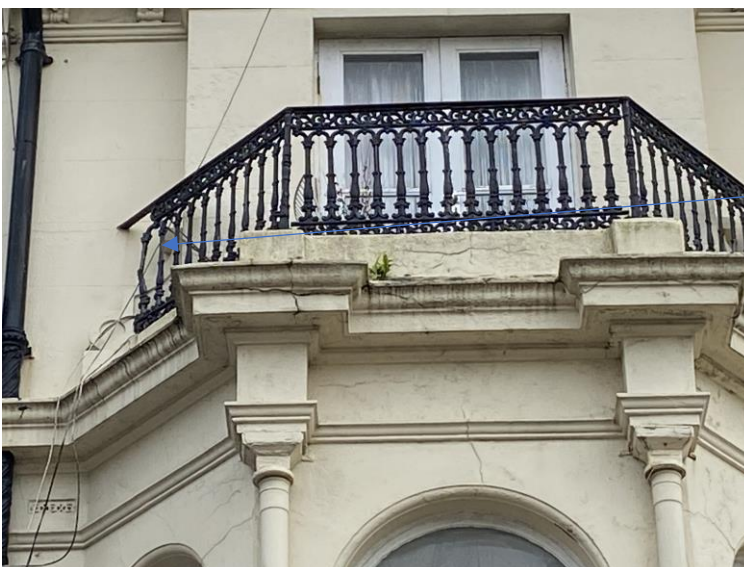
36.

There are cast-iron bay window railings to the ground floor windows. These are suffering from corrosion. Cast-iron balustrades to the second-floor balcony are also suffering from corrosion and the spindles on the north side of the balustrade are damaged.

Cracked render to bay window cornice and vegetation growth.

Corrosion to bay roof balcony balustrade and damaged spindle on the north side.

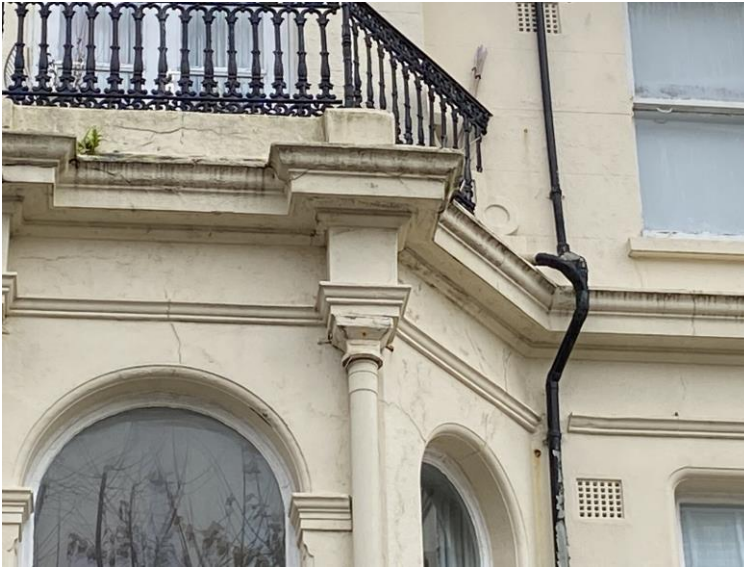
37.

The decorative spiral cast-iron downpipe on the north side of the front elevation is in a satisfactory condition. On the south side of the bay window, there is an old wastepipe which is suffering from paint delamination.

Deteriorated paint finishes to the front elevation wastepipe.

- Redecoration of the cast-iron downpipes, uPVC downpipes and the front wastepipe.
- Replacement of the cast-iron soil and vent pipe with a uPVC soil and vent pipe.

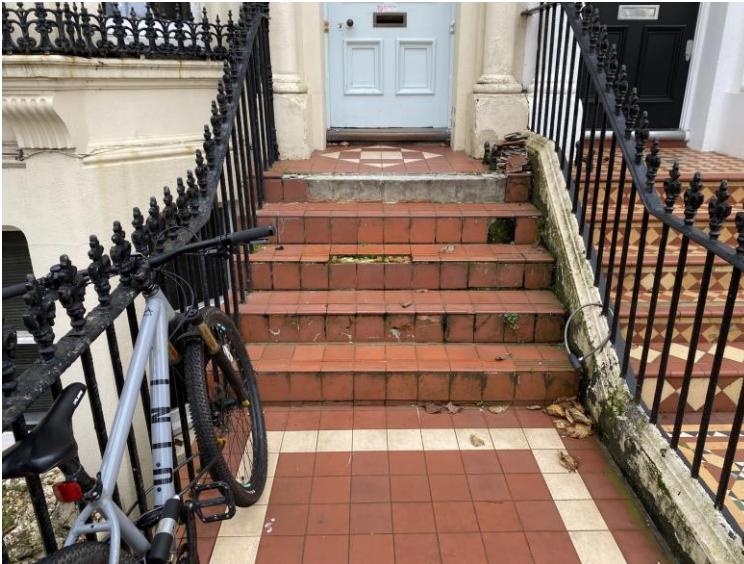
38.

Multiple quarry tiles to the entrance pathway are damaged and detached.

Damaged and missing quarry tiles to the entrance steps.

- Replacement of defective tiles to the entrance pathway.

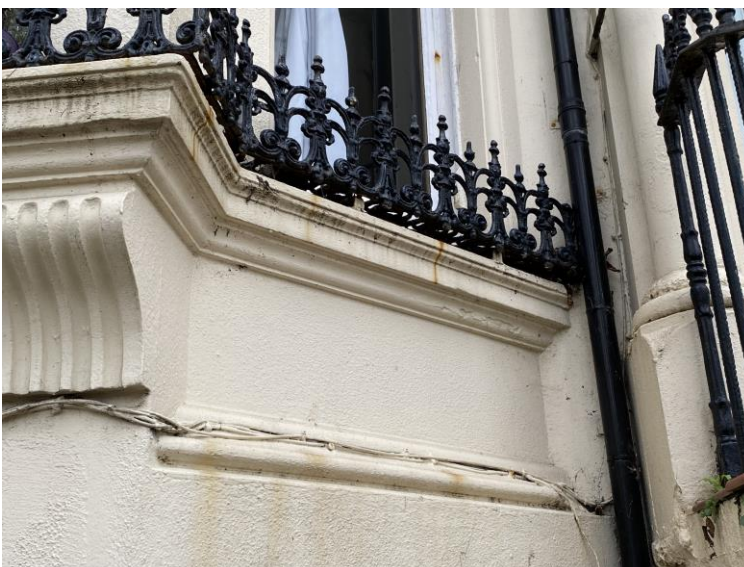
39.

Corrosion to front ground floor railings.

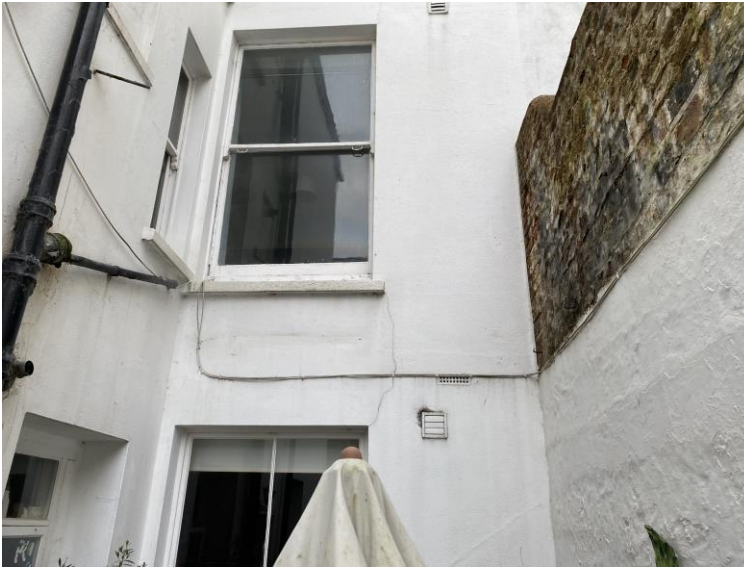
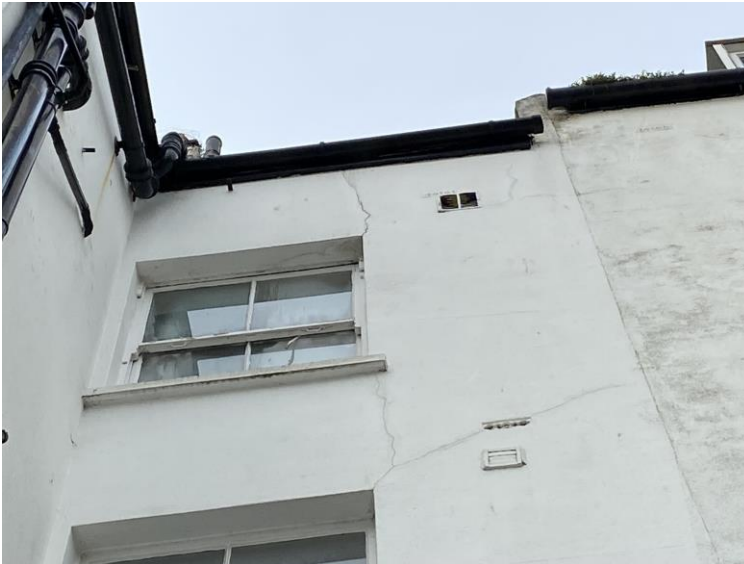
Cracked render to the rear elevations.

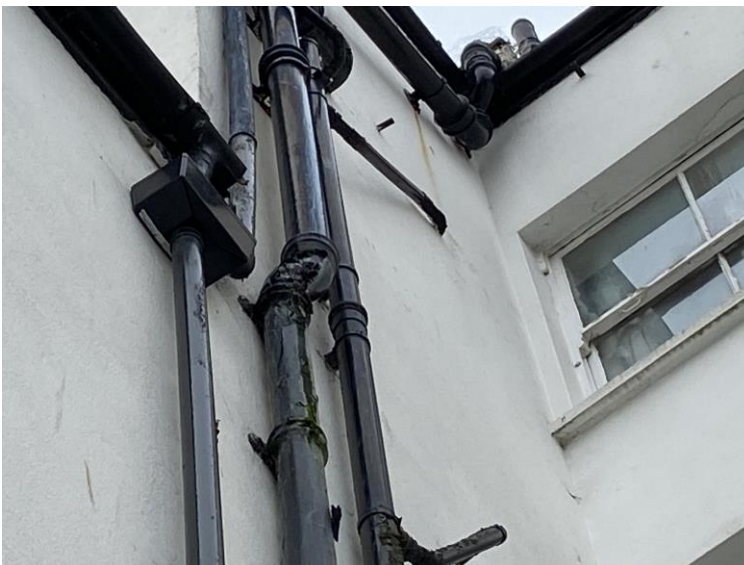
42.

On the rear elevations, there are several cast-iron downpipes which are suffering from paint delamination and localised corrosion. In addition, the uPVC downpipes are experiencing flaking paintwork.

There is a cast-iron soil and vent pipe (SVP) mounted on the side of the four-storey projection. I believe the pipe is cracked and leaking at the pipe bend which is in line with the two-storey projection roof.

Deteriorated rear uPVC downpipes and cracked and leaking cast-iron soil and vent pipe.

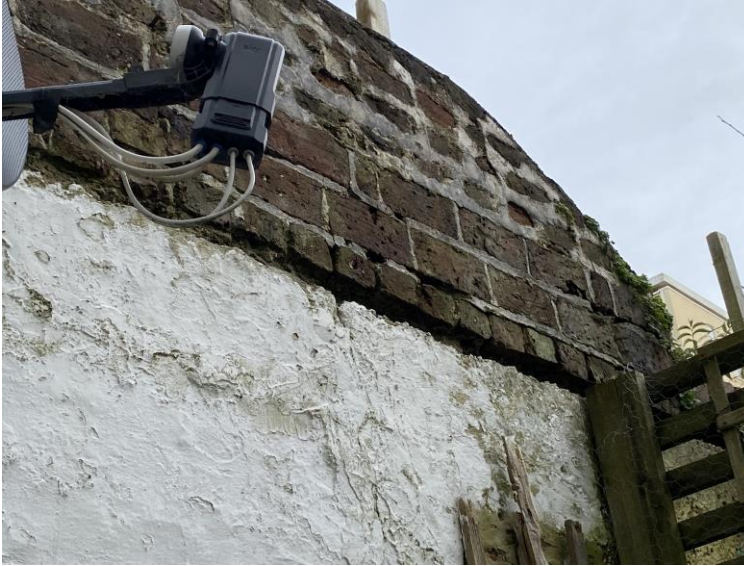
43.

The rear north bungaroosh boundary wall is suffering from isolated areas of deterioration, particularly to the high-level mortar joints.

Deterioration to the rear north garden boundary wall.

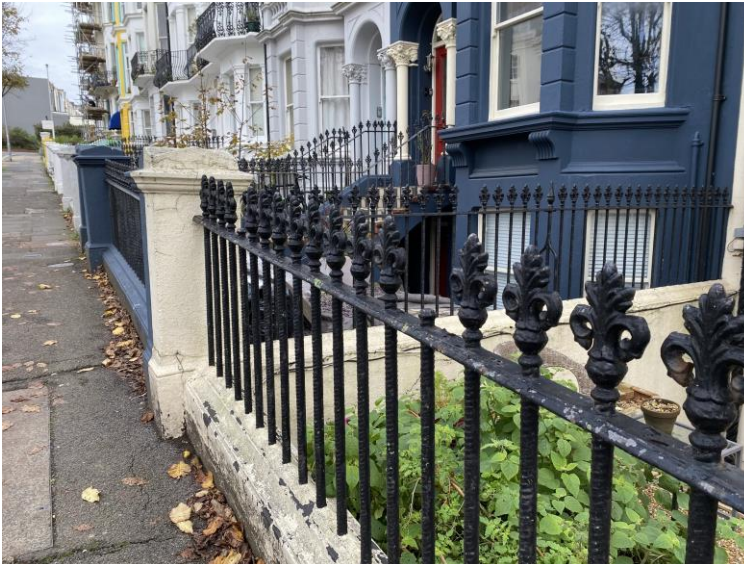
44.

Metal railings to the front boundary are suffering from paint delamination and localised corrosion.

Flaking paintwork and minor corrosion to front garden railings.
