# Planned Preventative Maintenance Survey Report

## Example 10-Year PPM

Property Name  
Property Street Address  
Property Town/City  
Property Post Code

Sussex Surveyors  
May 2021

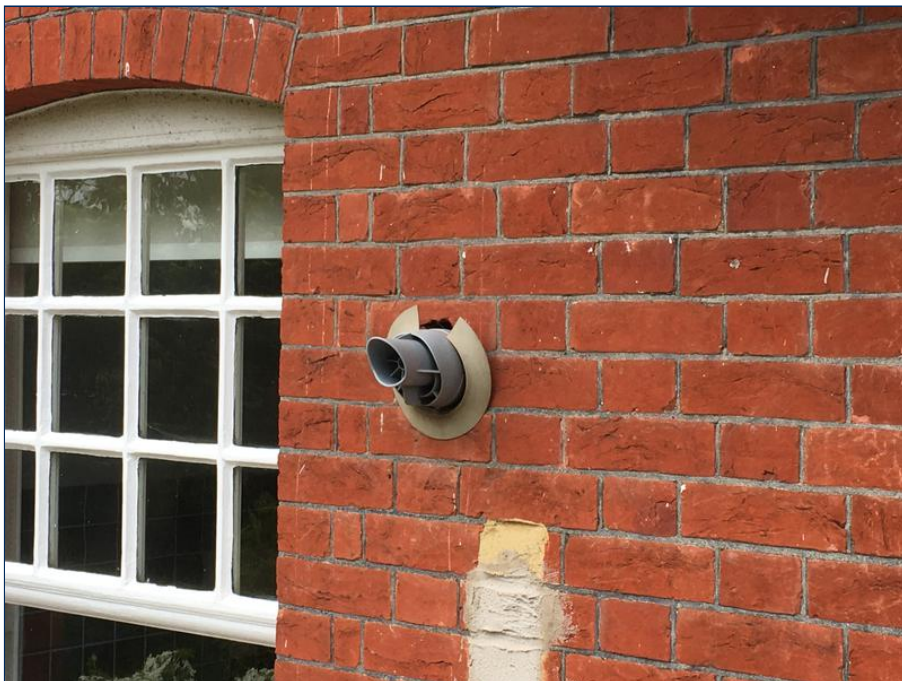
Photo 30 - Damaged collar
