# BUILDING SURVEY

NOVEMBER 2024

- 2.1.1 XXXXXXXX comprises a large detached two storey house, constructed in the 1930s. Originally, the property was constructed to a high standard for the period, using similar quality materials and workmanship. The Vendor has owned the property for 47 years, during which time there have been minimal major alteration works. They did, however, have a swimming pool installed and the tennis court restored shortly after taking occupation. Further alterations include the construction of workshop outbuildings in the northwest corner of the garden and replacement of the boiler many years ago.

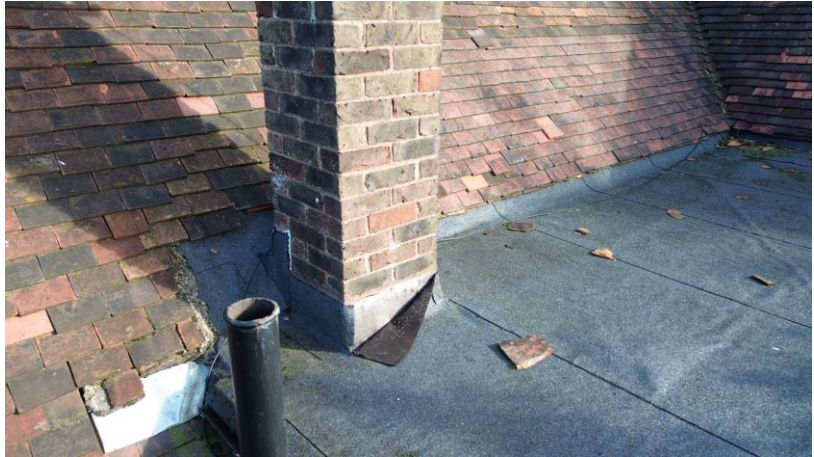
- 3.1.11 Felt flashings are in place to the front chimney stack which forms part of the felt covered flat roof over the projection. These flashings have been installed to a poor standard and have pulled away from the chimney stack. Whilst no signs of water ingress were recorded during our visit, there is a high risk of this in future. As such, felt flashings should be replaced with good quality code 4 lead flashings in the short term.

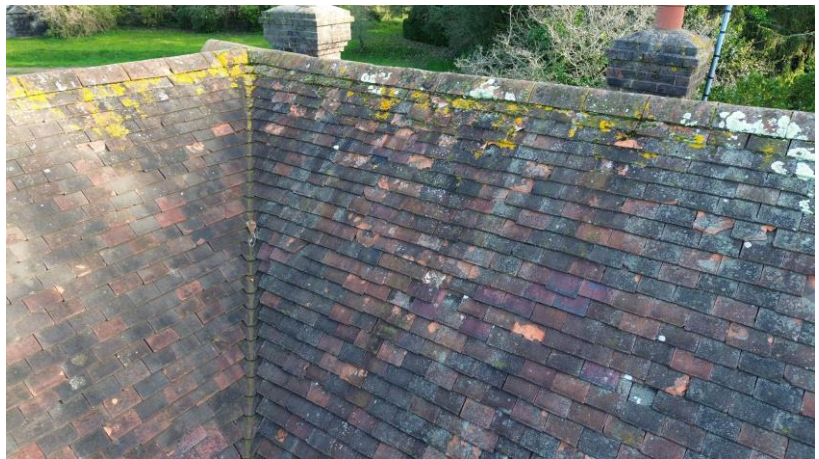
- 3.2.2 Clay tiles are affected by a process of deterioration called delamination. This occurs when sun and frost act upon the porous tile surface causing it to break down. Most of the roof tiles, which are believed to be original, have exceeded their expected trouble-free lifespan, as evidenced by widespread delamination, broken tiles, and slippage across all roof pitches, with the east and rear pitches in the worst condition. Mortar bedding to the hip tiles, ridge tiles, and verge tiles has deteriorated significantly in several areas. Although some tiles have been replaced over the years, deterioration remains prevalent throughout.

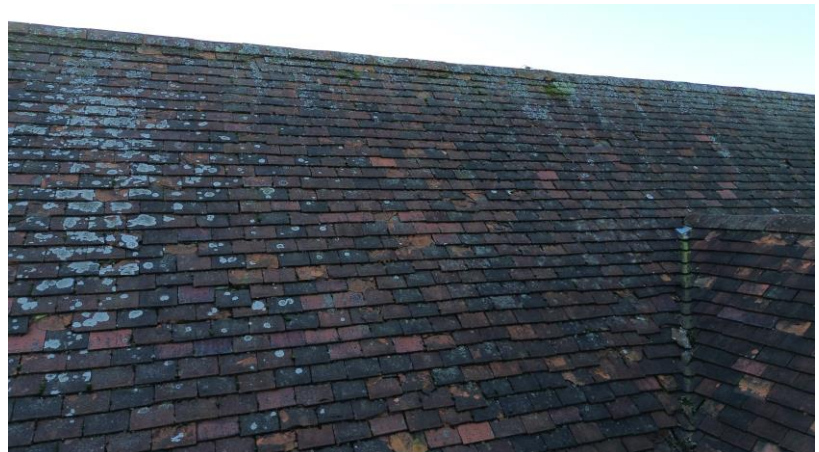
- 3.2.3 An old felt underlay exists between the roof tiles and timber close boarding, which is unexpected for a roof of this age. Typically, 1930s roofs

have tiles fixed directly to timber battens attached to close boarding. This underlay highlights the high quality of the original construction. Its purpose is to provide a secondary layer of protection against moisture ingress, and we suspect its presence has helped to prevent water entry through deteriorated or slipped tiles. However, due to the underlay's age and likely prolonged exposure to moisture, its remaining lifespan is limited.

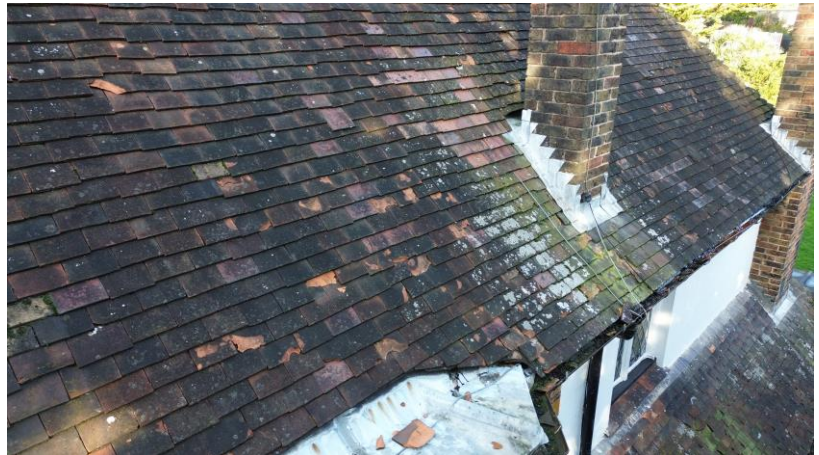
- 3.2.4 In view of the widespread deterioration, it is more practical and cost effective to remove and replace the roof covering bearing in mind these tiles have far exceeded their serviceable life and will become an ever-increasing maintenance liability. We therefore recommend stripping the roof and installing a new tile covering over a modern breathable felt underlay with new battens. Insulation will also need to be installed to comply with Building Regulations (Part L). The timber close boarding can remain in place. Ideally, these works should be carried out within the next few years. Many of the original tiles remain in satisfactory condition and could potentially be reused. Our budget costs at the end of this report reflect this approach.

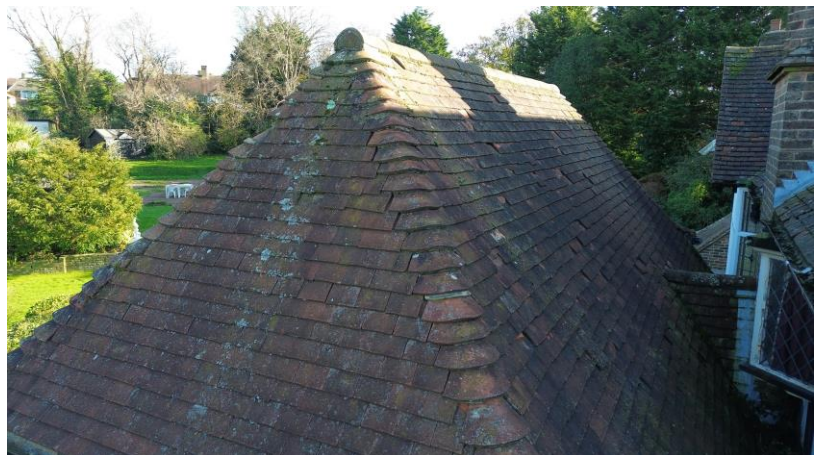
- 3.2.5 Tiles to the garage roof are in better condition, although there are numerous slipped broken and delaminated tiles. In addition, the ridge and hip tile bedding has deteriorated and there are several missing hip tiles. Defective roof and hip tiles should be replaced and the hip tiles re-bedded in the short term.

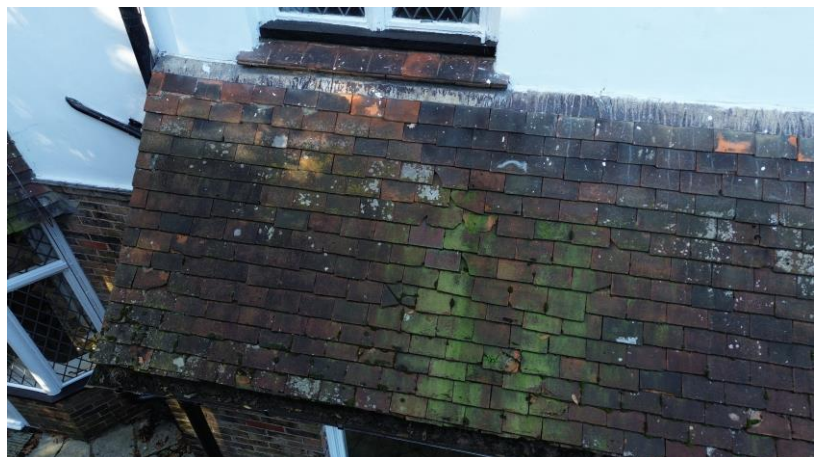
- 3.2.6 Additional pitched roofs cover the east elevation bay/chimney breast and the northeast projection. Numerous roof tiles on these sections are defective and should be replaced in the short term. The mortar bedding to the hip tiles has deteriorated, resulting in slippage. As part of the roof overhaul, the hip tiles should be re-bedded, and hip hooks should be installed at the eaves to prevent future slippage.

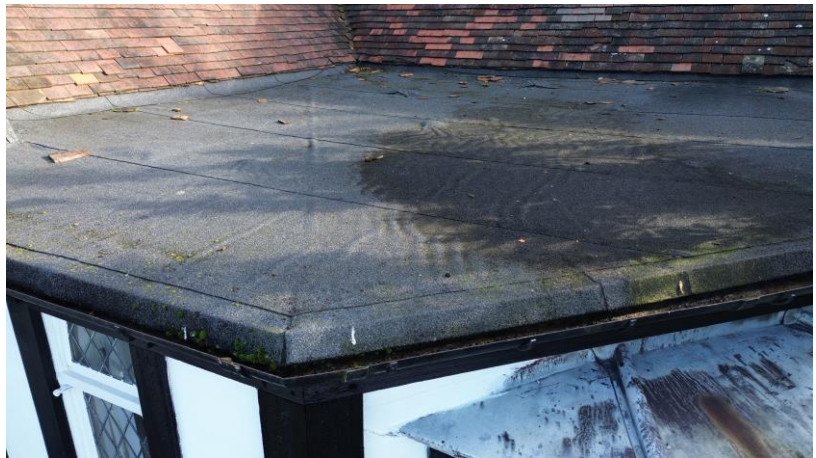
- 3.3.1 There is a mineral felt covered flat roof over the front projection which looks to have been installed within the last 10-years. Unfortunately, this has been installed to a poor standard and is badly rippled which suggests it was not adequately adhered to the roof at the time of installation. As mentioned, the substandard felt flashings which connect to this flat roof have peeled from the front chimney stack.

The substandard installation of this flat roof covering creates a risk of wind-up lift. In addition, the rippled sections are prone to splitting which can lead to water ingress. We recommend that this flat roof is re-covered using a 3-layer high performance bitumen felt system in the short term. The new covering should incorporate 120mm of PIR insulation to ensure the 0.18 U-Value requirement under Part L of the Building Regulations.

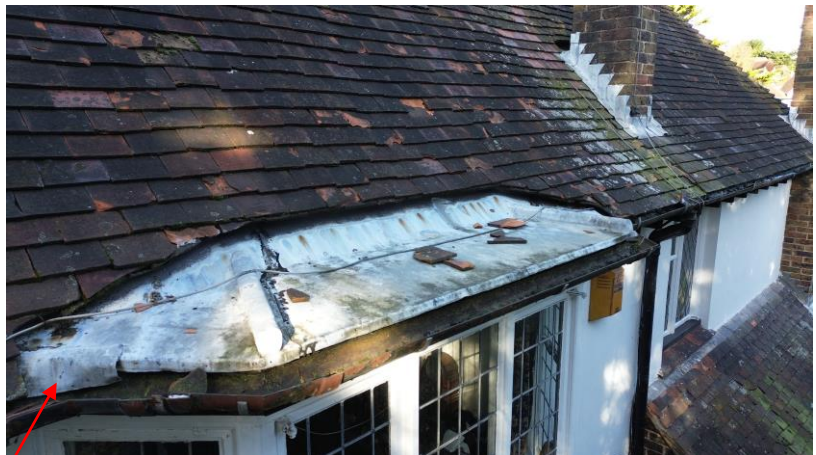
- 3.3.2 There are a series of lead clad flat roofs over bay and oriel window roofs. These are aged and worn, although most remain in satisfactory condition. However, the lead flat roof over the east bay to Bedroom 5 is deformed and aged. Internally, we found evidence of leaks to the bay ceiling and there is a patch repair in this location externally on the flat roof. We recommend that this flat roof covering is replaced in the short term.

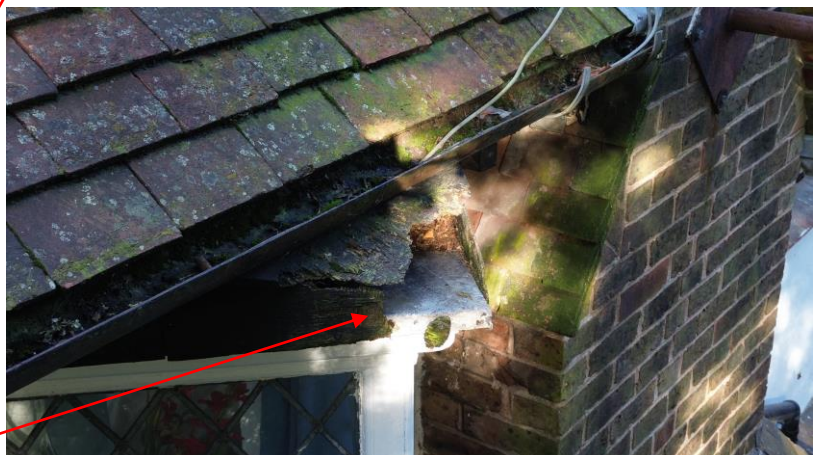
- 3.3.3 The flat roof covering over the east facing oriel window to Bedroom 6 has perished, exposing the timber substrate which is badly rotten. We were surprised to find that this flat roof is not currently leaking, although there is a high risk of this in the near future.

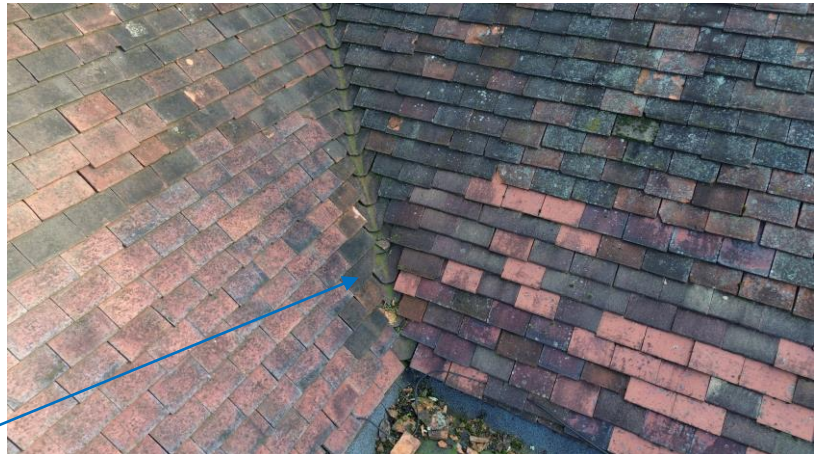
- 3.5.1 There are tile lined valleys on the front where the two main roofs meet in the centre, and either side of the gable projection on the north pitch. The front valley is in poor condition, as the roof tiles do not align properly with the valley tiles, resulting in gaps. This creates a significant risk of water ingress and is likely relying on the felt underlay to prevent water penetration, which is considered poor practice.

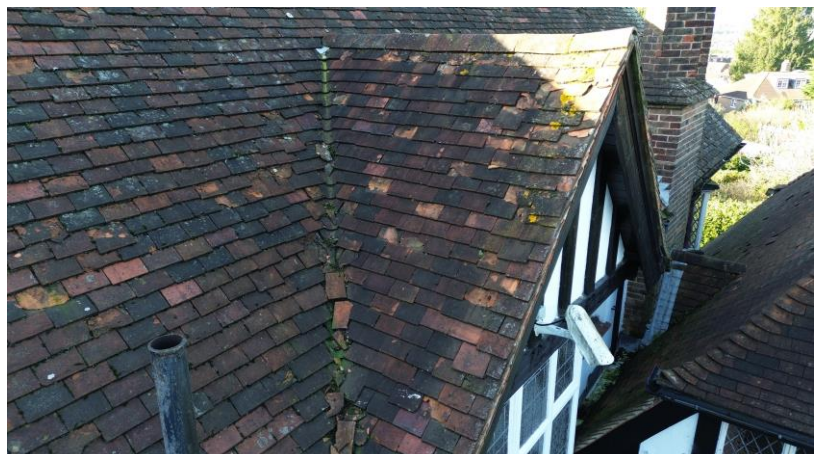
- 3.5.2 Valleys either side of the gable projection are also in poor condition with widespread tile breakage. As part of the roof overhaul, valley tiles should be replaced. It is crucial that these works are carried out by a competent roofing contractor who will ensure the roof is correctly gauged, so that the roof tiles align properly with the valley tiles.

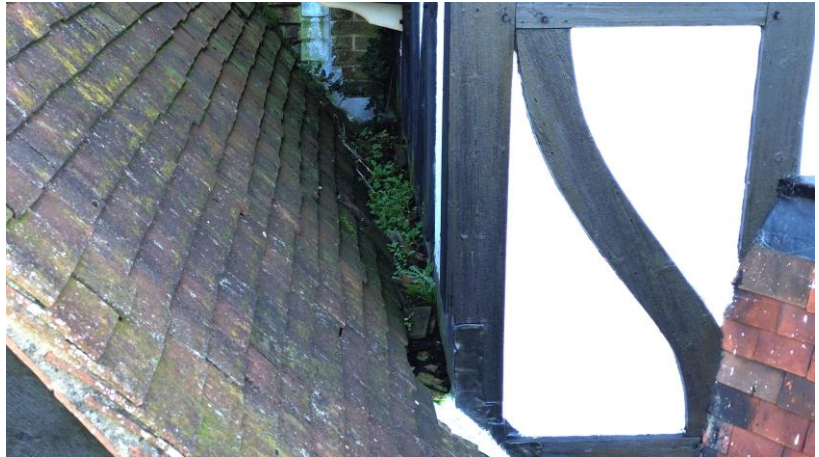
- 3.5.3 There are lead lined valleys, either side of the chimney stack on the north elevation, which separate the garage roof from the north elevation. These are heavily blocked with leaves and debris. Valley gutters must be cleared now and regularly thereafter. As part of the short-term clearance, the valley linings should be checked and allowances for repairs made.

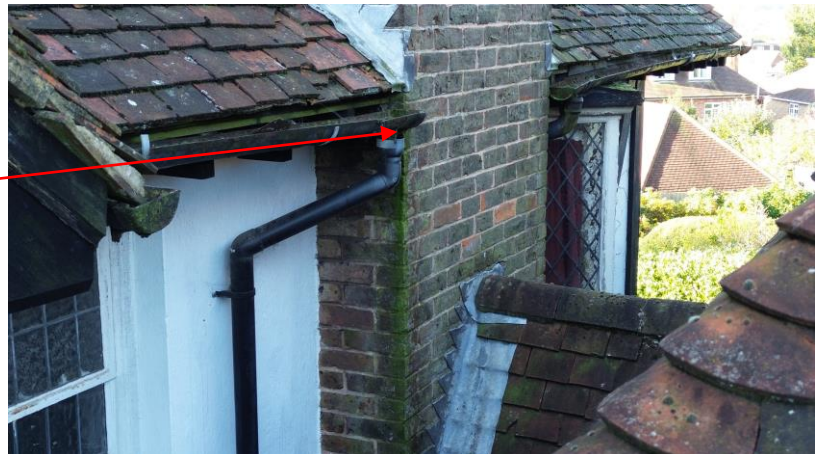
- 3.6.2 Rainwater goods to the property predominantly comprise cast-iron gutters and downpipes with some uPVC gutters and downpipes in areas. Downpipes drain to gullies which either connect into the foul drainage or to a soakaway somewhere within the grounds. Cast-iron rainwater goods are corroded throughout and are leaking in isolated areas. We recommend that these are redecorated using proprietary metal coatings in the short term, and defective sections should be replaced. Stop-ends are missing from some of the east elevation gutters, and new stop-ends should be fitted as part of the rainwater goods repairs. Gutters are also blocked with vegetation in areas, and this should be cleared now and regularly thereafter. Gullies must also be unblocked now.

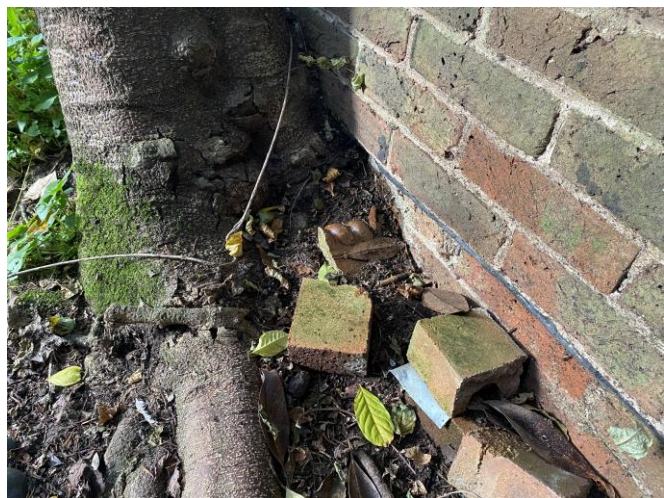
- 3.7.3 All walls are plumb and square and are free from any major cracking or distortion. We did, however, note bulging to the brickwork on the south wall of the entrance porch which has occurred due to the growth of the tree beneath the wall. Although Magnolia trees typically have shallow root systems, this tree's proximity to the wall has caused it to push outward. Whilst there are currently no signs of significant internal or external cracking, there is a strong likelihood of such damage developing in the future as the tree continues to grow. We therefore recommend that the tree and its stump be removed in the short term. The resulting void beneath the wall should be filled with concrete to maintain stability. Part of the wall might require rebuilding following the removal of this tree, and allowances for such works should be made.

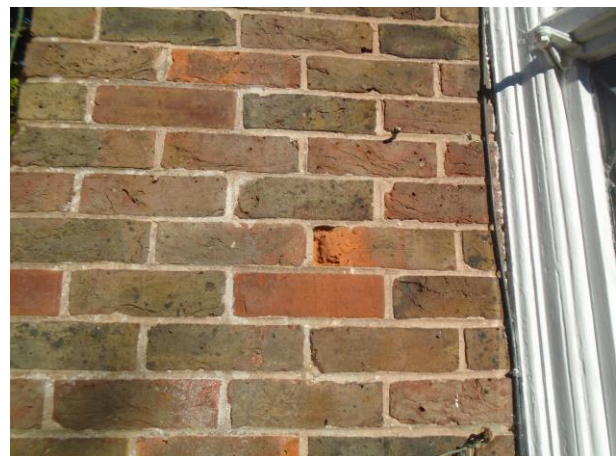
- 3.7.4 Brickwork and mortar and mortar joints are generally in a good condition throughout, subject to isolated areas of deteriorated mortar joints and some spalled bricks to the front of the south wing. We also noted old fixing holes to the southwest corner of the south wing, behind the downpipe. Localised repointing of the brickwork mortar joints should be carried out, defective bricks replaced, and old fixing holes filled in the short term.

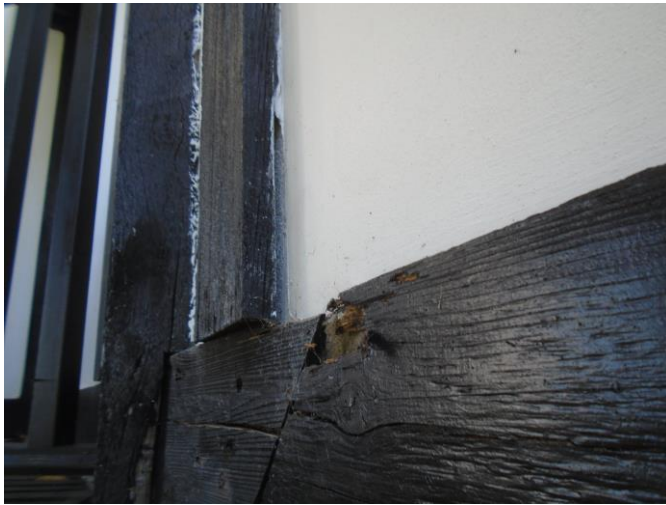
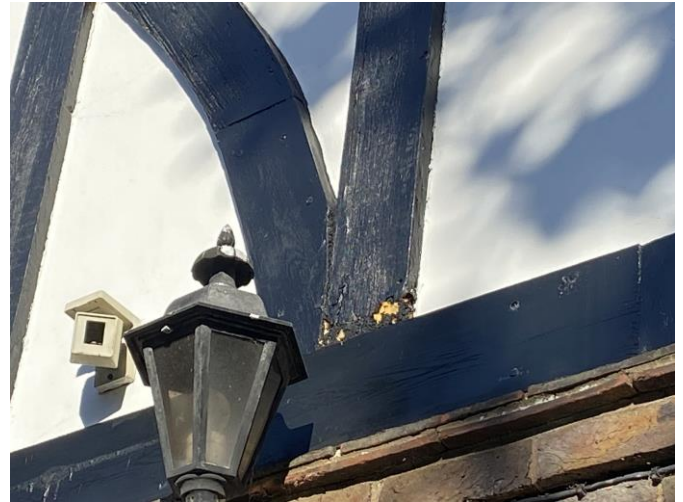
- 3.7.5 Render to the first floor is in a good condition throughout, although there are hairline cracks in areas. These are minor and can easily be filled during the course of routine external redecoration.
- 3.7.6 Cladding to the front, and front faces of both wings is decayed in areas. The detailing between the render and timber cladding is basic. Correct detailing involves the installation of a lead tray between the two which helps to prevent rainwater from sitting on the horizontal cladding boards, leading to decay. The absence of these trays has continued to wet rot decay. Rotten timber cladding should be cut out and replaced in the short term. On the west wall of the south wing, a vertical section of cladding is detaching adjacent to the balcony. This should be re-fixed in the short term.

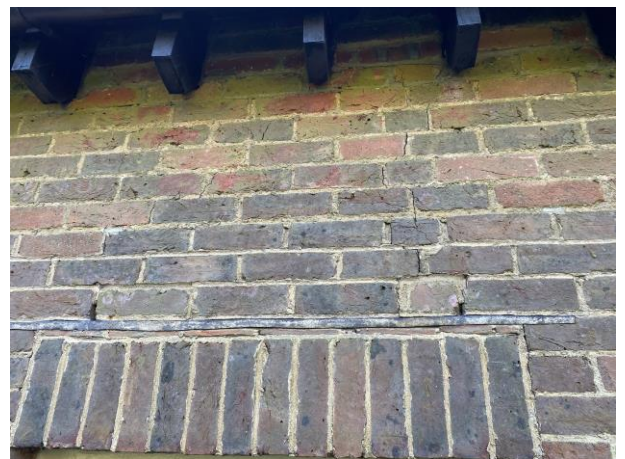
3.7.9 A building survey of this type is non-invasive; therefore, we have not been able to inspect the condition of lintels or beams over the windows and doors. We found no evidence of any major cracking or distortion to indicate any lintel defects or failure above most of the openings. Minor cracking is evident to the brickwork above the north facing garage window which is indicative of lintel defects. Whilst there are no concerning signs of deflection to the solidier course above the window, we recommend installing a new steel lintel to prevent possible deflection and more advanced cracking.

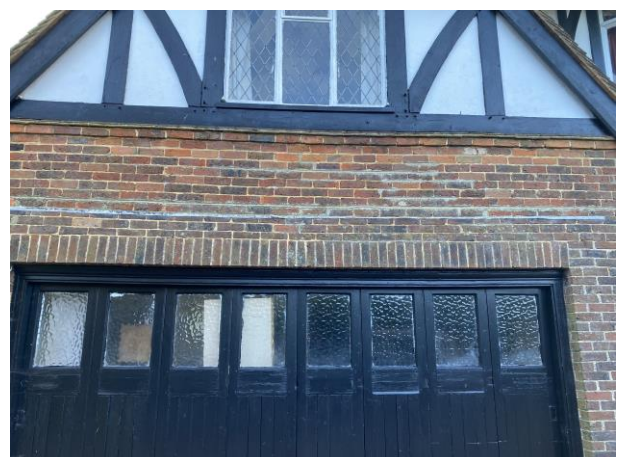
3.7.10 We suspect that the beam above the sliding timber garage doors is deflecting, as the brickwork above the doors is bowing in the centre, with a horizontal crack evident along one of the mortar joints. Previous repairs and repointing are visible in this area; however, the re-opening of the crack indicates an ongoing issue. We recommend further investigation by removing the internal finishes to reveal the doors. We have allowed for the installation of a new steel, in place of the existing beam, at the end of this report.

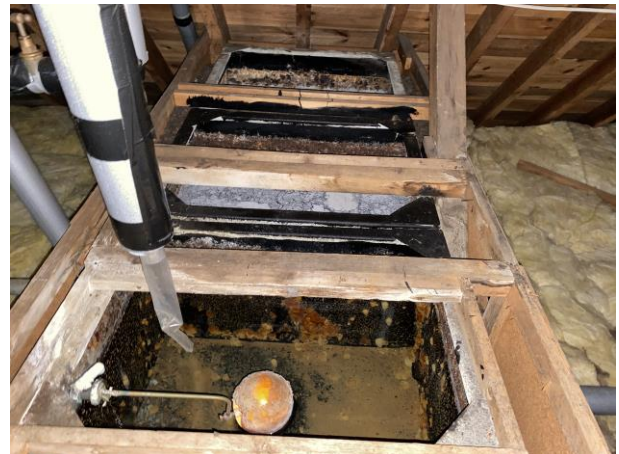
4.1.4 There are several old, galvanized steel cold water tanks in the roof space, adjacent to the loft hatch. These tanks are uncovered which can lead to contamination of the water supply. Inside the tanks, we observed significant rusting of the linings, which can further contaminate the water and, in extreme cases, promote the growth of Legionella bacteria. The water in the tank is heavily soiled. We strongly recommend decommissioning these tanks immediately.

4.1.5 We recommend two options for addressing this issue. The first option is to replace the tanks with modern PVC cold water storage tanks. This will require the old tanks to be cut into pieces within the roof space before removal. However, it's important to note that gravity-fed cold-water systems are gradually being phased out due to their often-low water pressure and the risk of contamination.

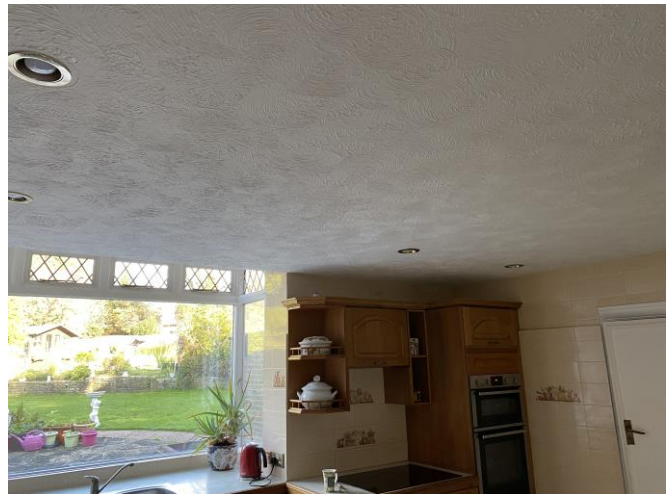
4.2.3 Ceilings to the kitchen, dining room, swimming pool equipment room and bedroom 6 have a textured paint finish. Certain textured coatings (Artex) are known to contain asbestos, and it is not possible to establish this from a visual inspection only. Care should be taken not to disturb these materials and testing carried out prior to any proposed ceiling works to confirm the presence of any asbestos. Asbestos is a hazardous material although in its current condition it is stable. It would nevertheless be prudent for you to skim over these ceilings in order to encapsulate any asbestos. Estimates should therefore be obtained from a competent plasterer in this regard. We do not consider this a priority given that the ceilings are in a stable condition. There are some hairline cracks in areas. These are minor and can easily be addressed (filled) during the course of routine property redecoration. That said, any filler used should not be sanded down as this may release asbestos fibres from the Artex, unless the correct Respiratory Protective Equipment is used, and the correct control measures are put in place.

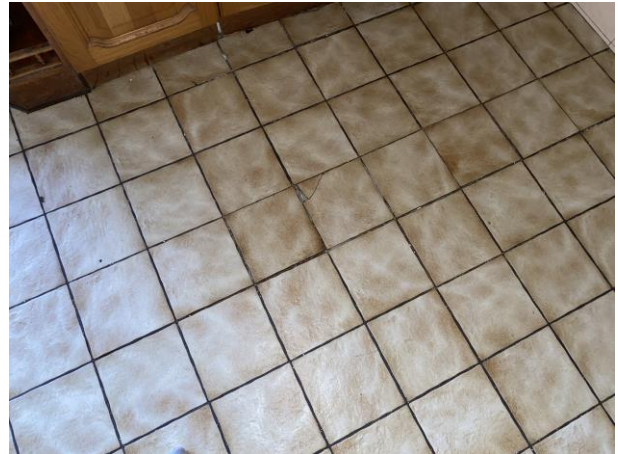
4.4.3 There is an unusual, raised area in the kitchen floor adjacent to the sink, with cracked tiles in this location. The cause of this is unclear, and we recommend further investigation to determine the underlying issue. If pipework is buried in the floor and has leaked in the past, it could have caused the floor and tile covering to lift. Once the cause has been identified and addressed, we recommend re-levelling the slab and installing new tiles.

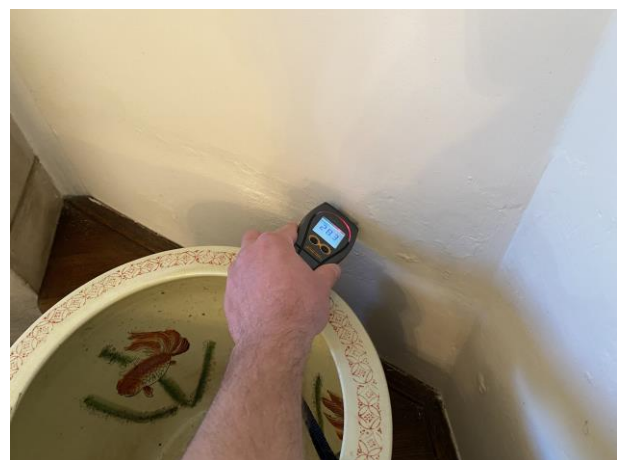
4.5.3 We took a series of moisture meter readings throughout the property and found evidence of dampness in two locations. Water damaged finishes were recorded to the open chimney breast in the drawing room, on the south side. Further high readings were taken from the east wall of the library at low-level. We suspect that the library damp is due to the external ground levels bridging the DPC. Reducing the ground levels below the DPC should prevent this. We suspect that damp to the drawing room chimney breast is due to deteriorated brickwork and mortar joints. Defective brickwork should be replaced and the mortar joints repointed to prevent this.

4.5.4 For dampness to penetrate the internal leaf of a cavity wall, the cavity must either be blocked or insulated. Following external repairs, we recommend that several bricks are removed from the areas where damp is

present, and the cavity cleared of any blockages or saturated insulation. Any removed insulation should be replaced.

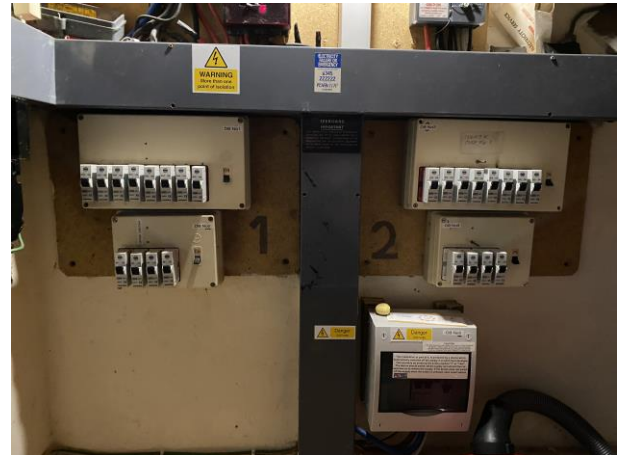
5.1.2 The switchgear and consumer units are located in the cupboard under the stairs. There are several consumer units, many of which are very old with one more modern smaller unit that was replaced in 2016, according to a Building Control Application we located on the council's website. Given the age of the consumer units, we strongly advise that these and the overall electrics are tested by a NICEIC registered electrician before exchange of contracts. In addition, old single insulated lighting cables were observed in several areas of the house as well as pre-1960s plug socket plates and light switches. This suggests that the house has not been re-wired for many years.

5.1.3 It is highly likely that complete re-wiring of the house is necessary in the short term, in addition to replacement of the old consumer units, and we have allowed for this within our budget costs at the end of this report.

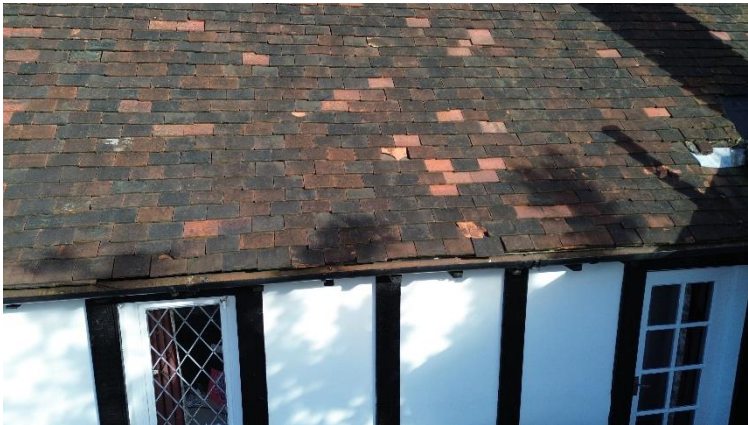
2.

Delamination and broken tiles to the south pitch of the north wing.

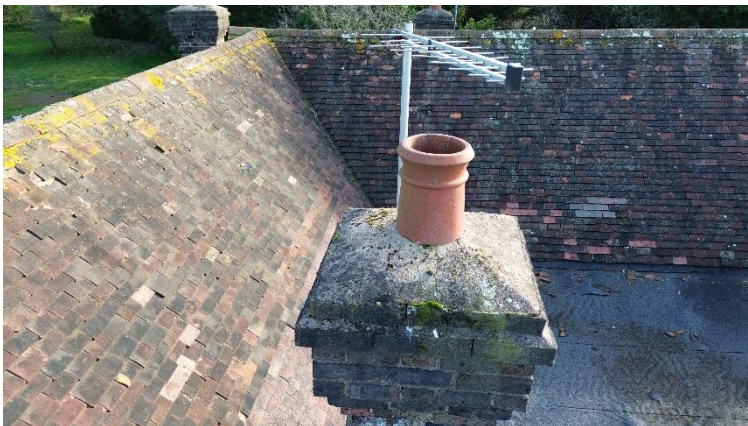
3.

Cracked flaunching to the front stack.

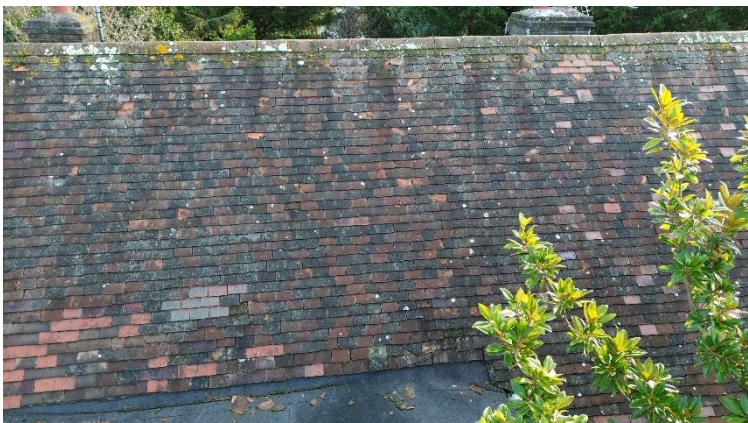
4.

Widespread delamination to the east pitch of the south wing.

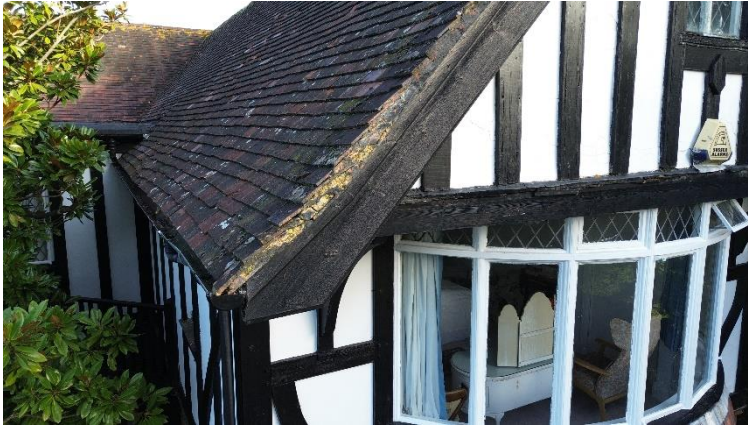
5.

Deteriorated verge tile bedding.

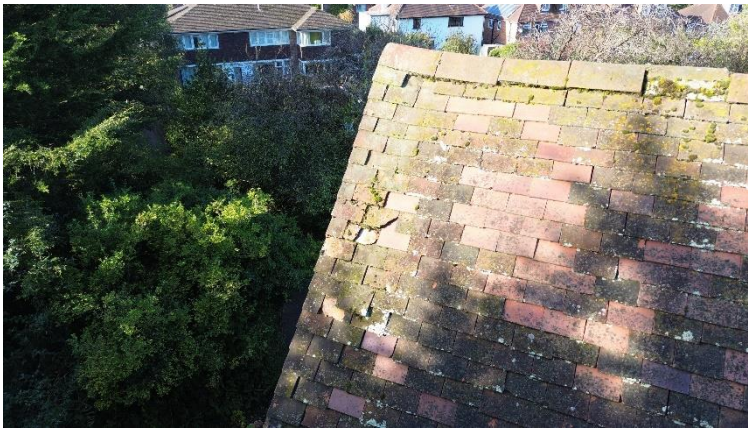
6.

Broken and delaminated clay tiles to the east pitch.

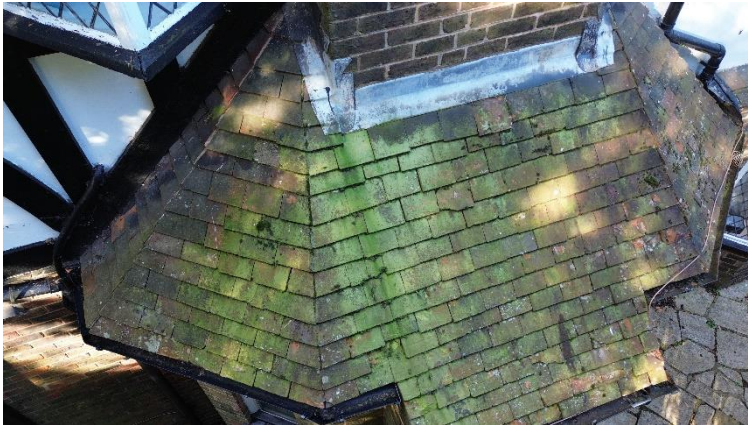
7.

Defective tiles to the east bay.

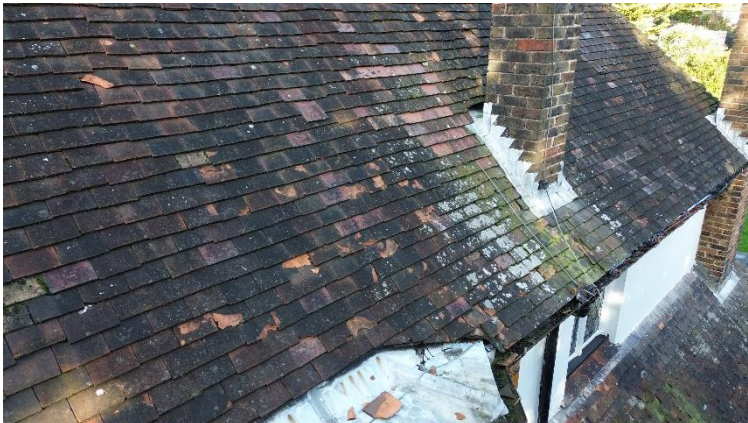
8.

Broken and delaminated clay tiles to the east pitch.

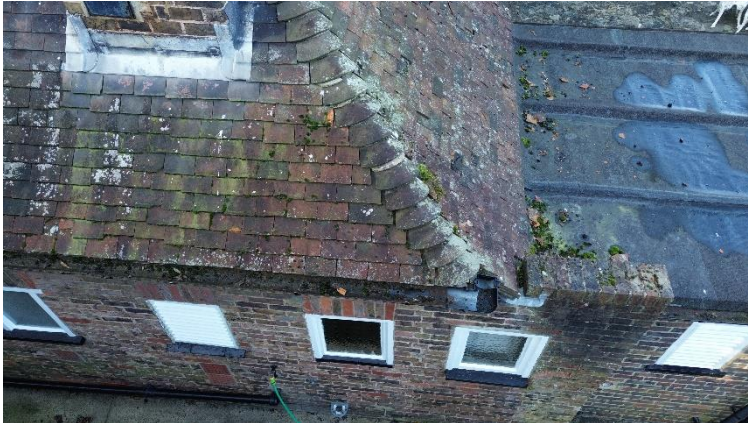
9.

Slipping hip tiles to the northeast projection.

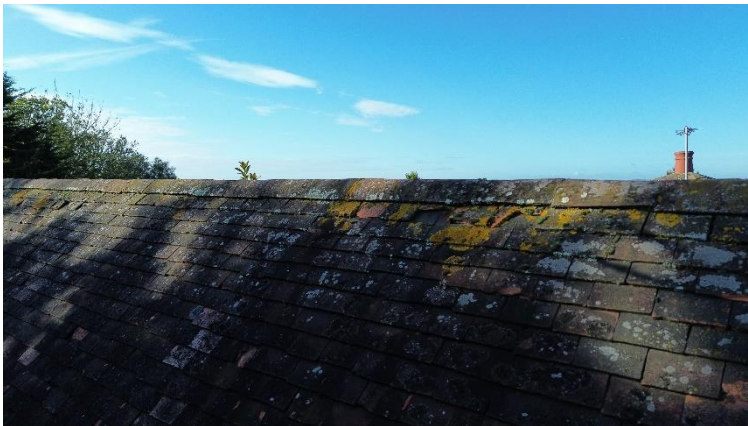
Deteriorated ridge tile bedding.

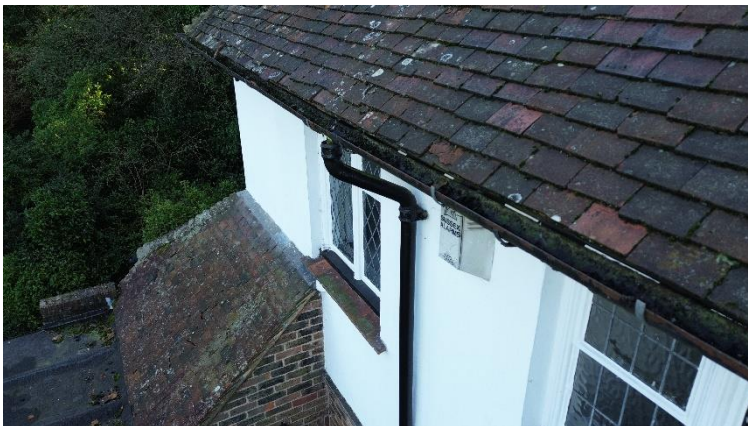
Corroded rainwater goods.

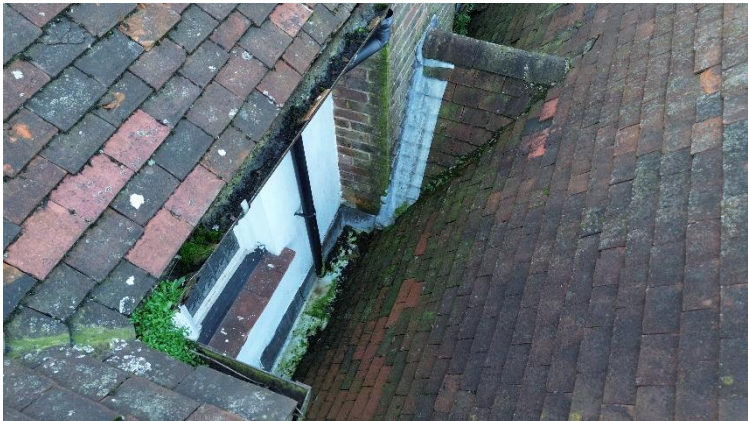
Blocked rear gutters.

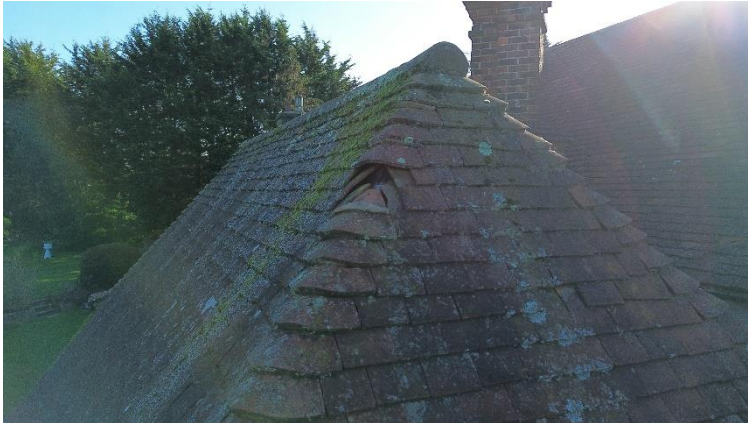
Broken and missing tiles to the garage roof.

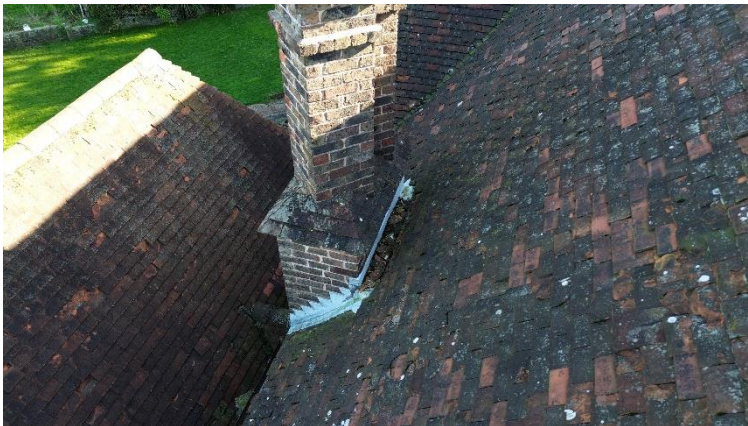
Blocked back valley to the rear stack.

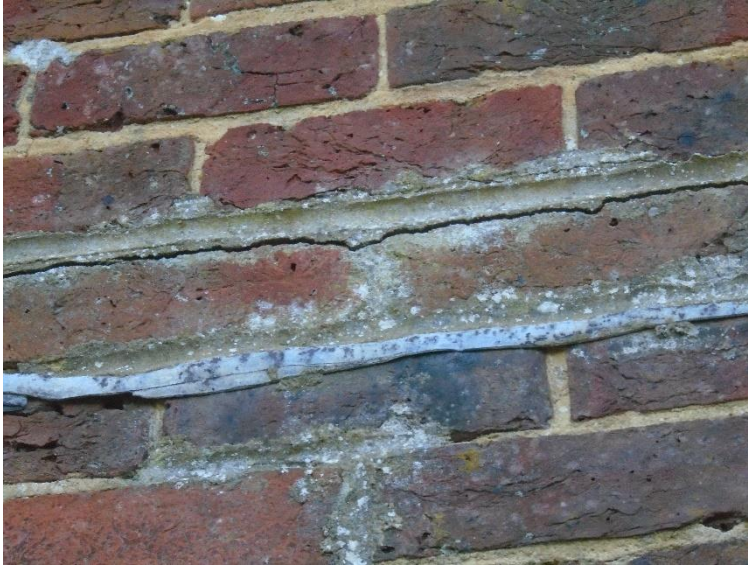
Cracking over the garage doors.

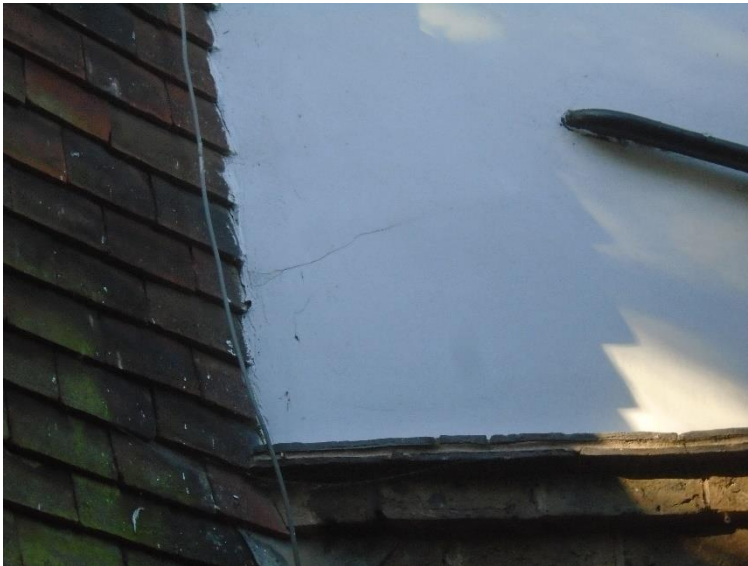
Hairline cracks to the east elevation render.

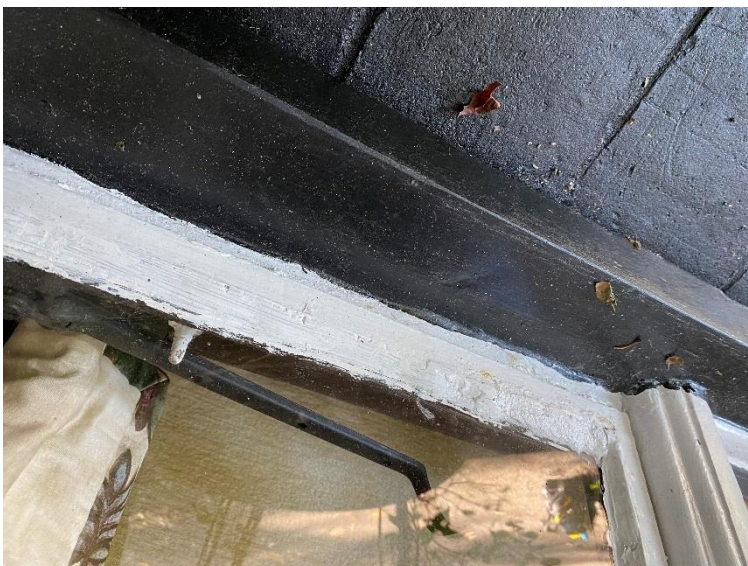
Deteriorated steel windows.

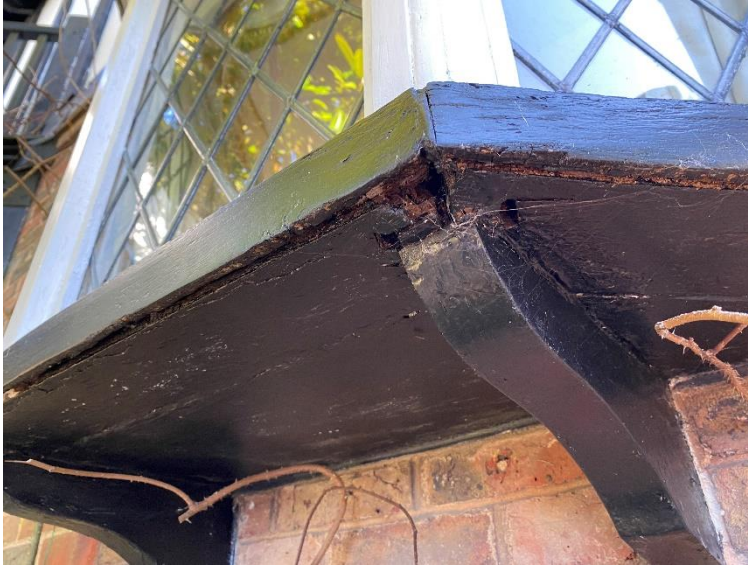
Rotten timber to the drawing room oriel window.

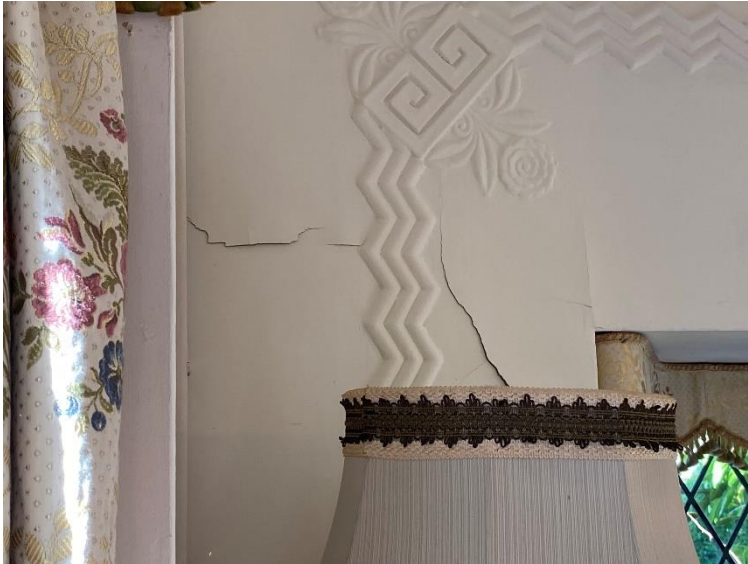
Cracking to internal finishes in the drawing room.

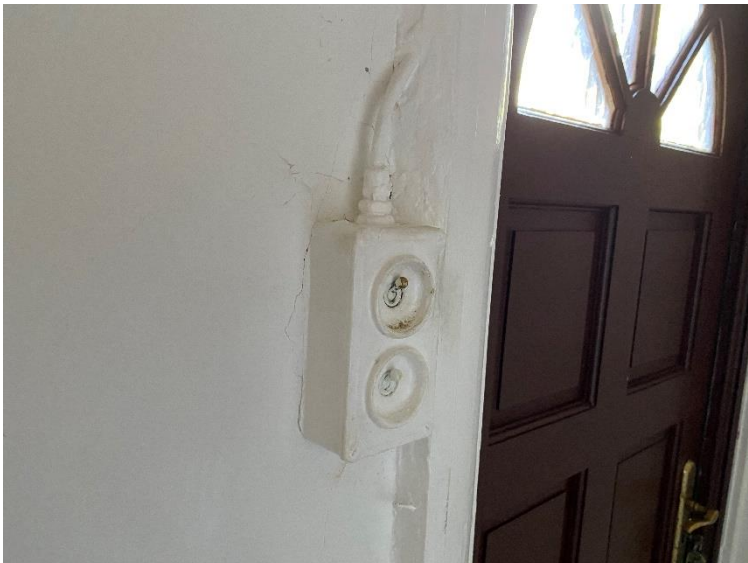
Old light switches.

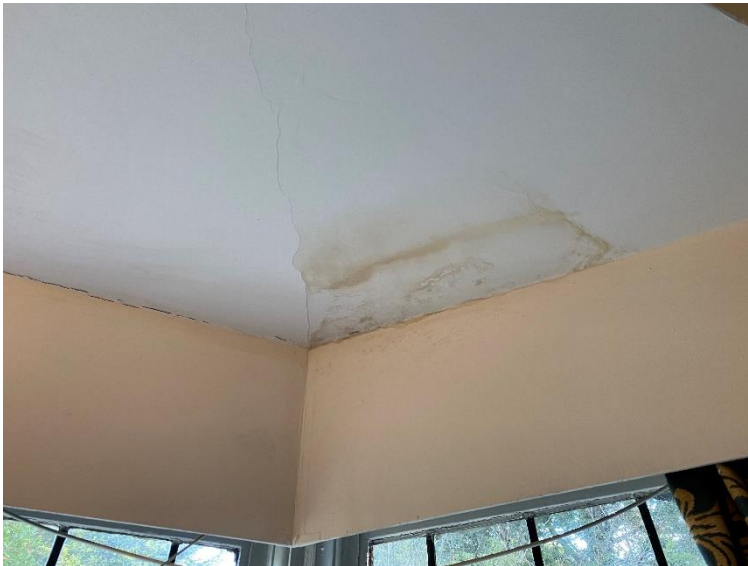
Water staining and damaged to  
bedroom 5's bay window ceiling.

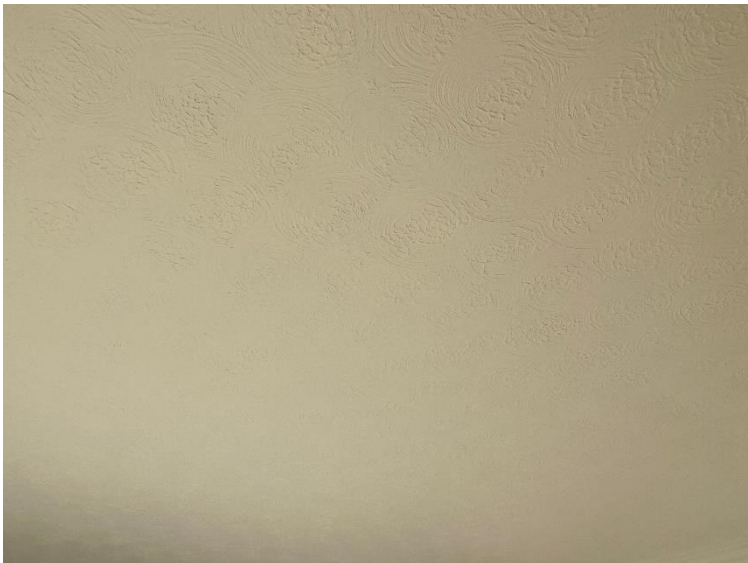
Textured ceiling finish to bedroom 6.

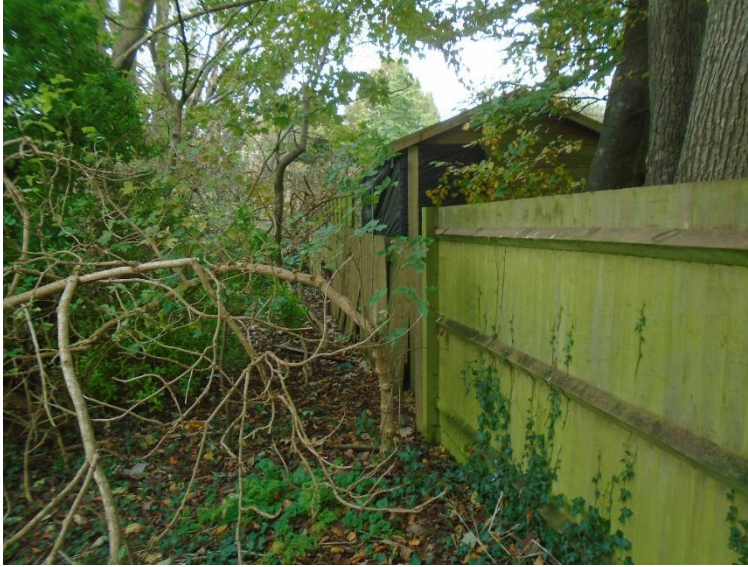
Damaged north boundary fence panels.

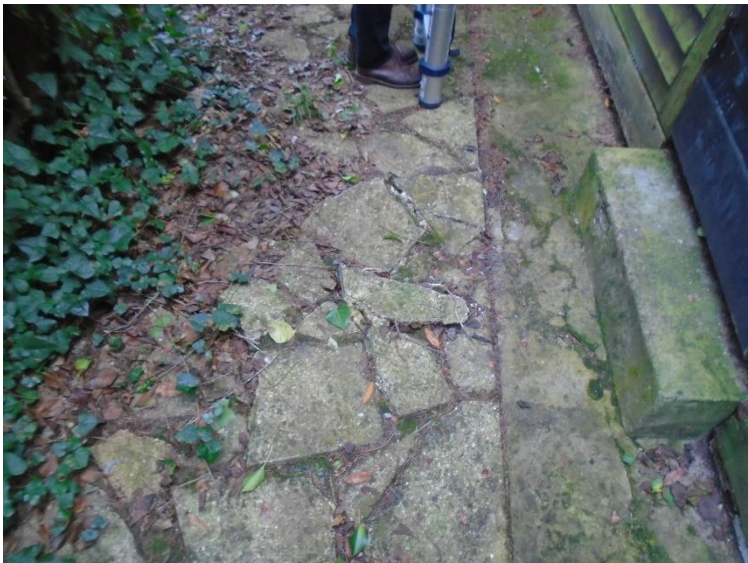
Raised and loose paving adjacent to the east shed.

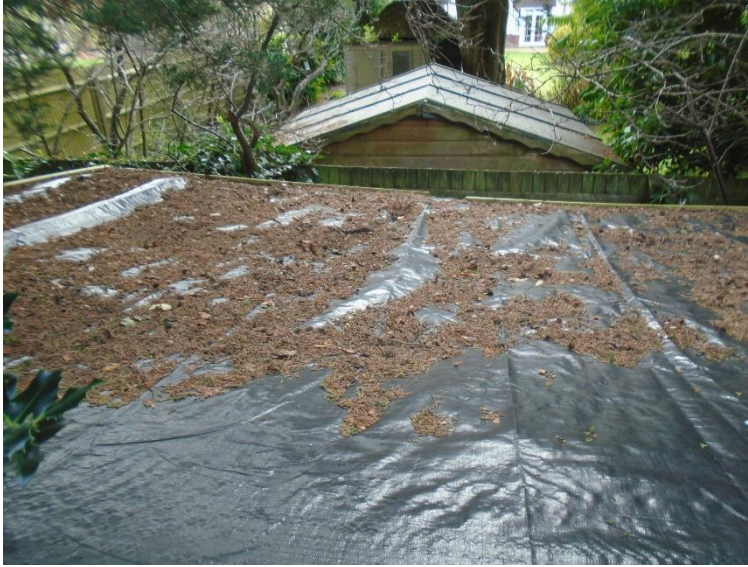
Failed roof covering over the east shed.

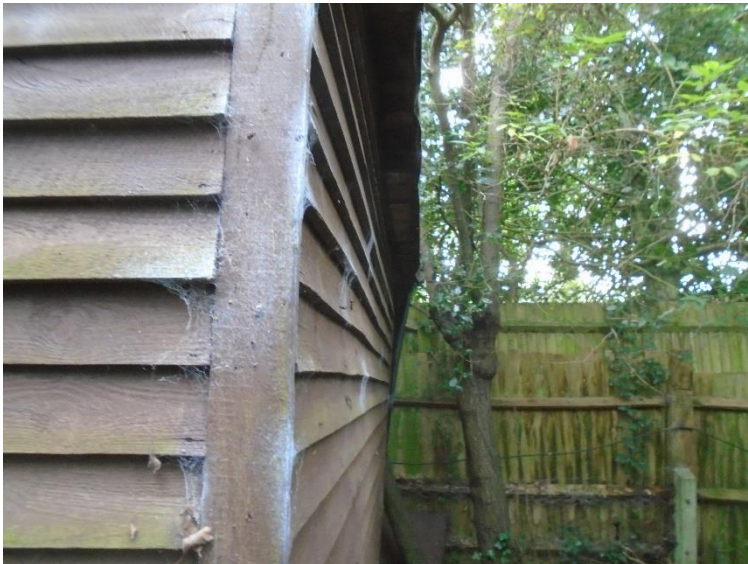
Leaning east shed.

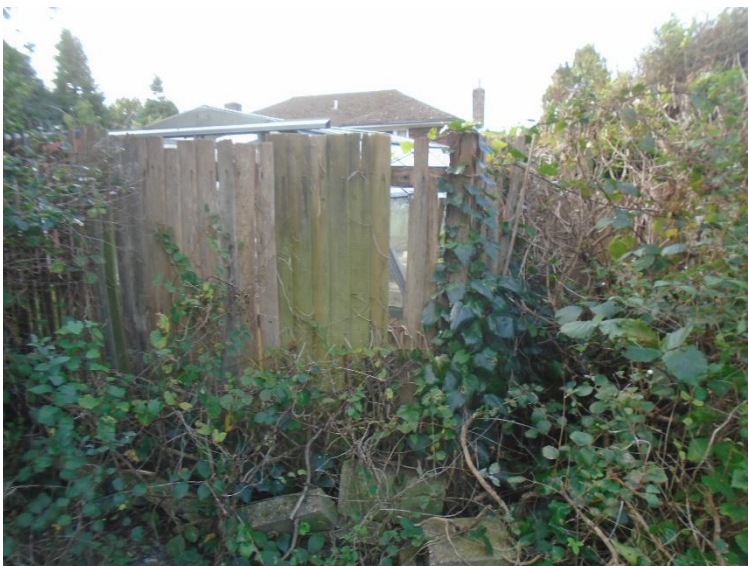
Damaged west boundary fence.

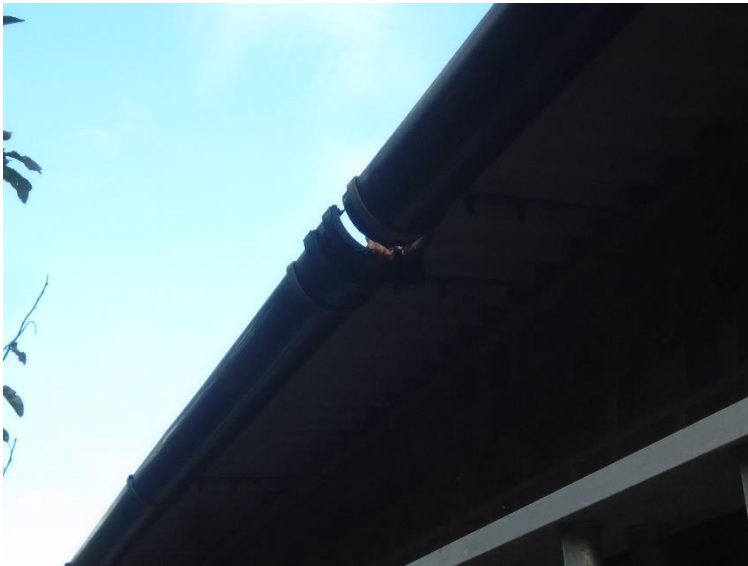
Defective gutters to the workshop.
