# BUILDING SURVEY

NOVEMBER 2024

- 2.1.1 XXXXXXXX comprises a large detached two storey house, constructed in the 1930s. Originally, the property was constructed to a high standard for the period, using similar quality materials and workmanship. The Vendor has owned the property for 47 years, during which time there have been minimal major alteration works. They did, however, have a swimming pool installed and the tennis court restored shortly after taking occupation. Further alterations include the construction of workshop outbuildings in the northwest corner of the garden and replacement of the boiler many years ago.

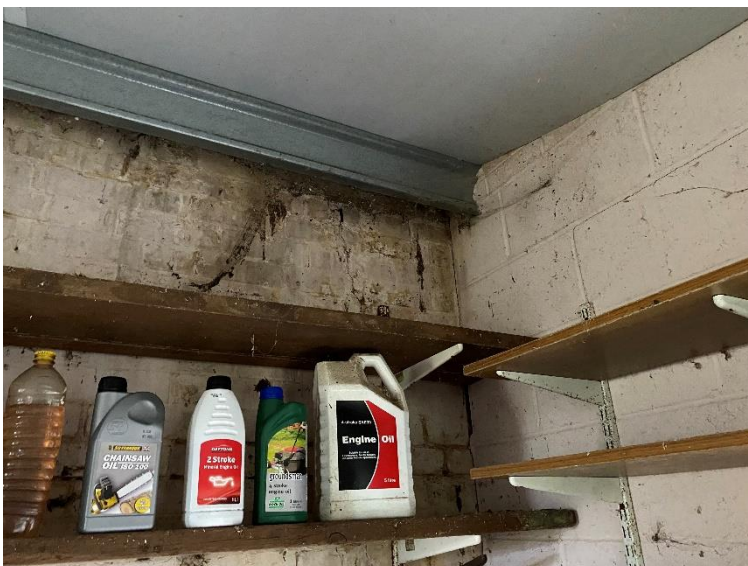
Evidence of leaks to the workshop.
