ARBORICULTURAL HAZARD EVALUATION SURVEY

Hassocks Parish Council

**Adastra Park
Parklands Copse
Talbot Fields**

Document ref: PJC/6907/25-01 Rev -

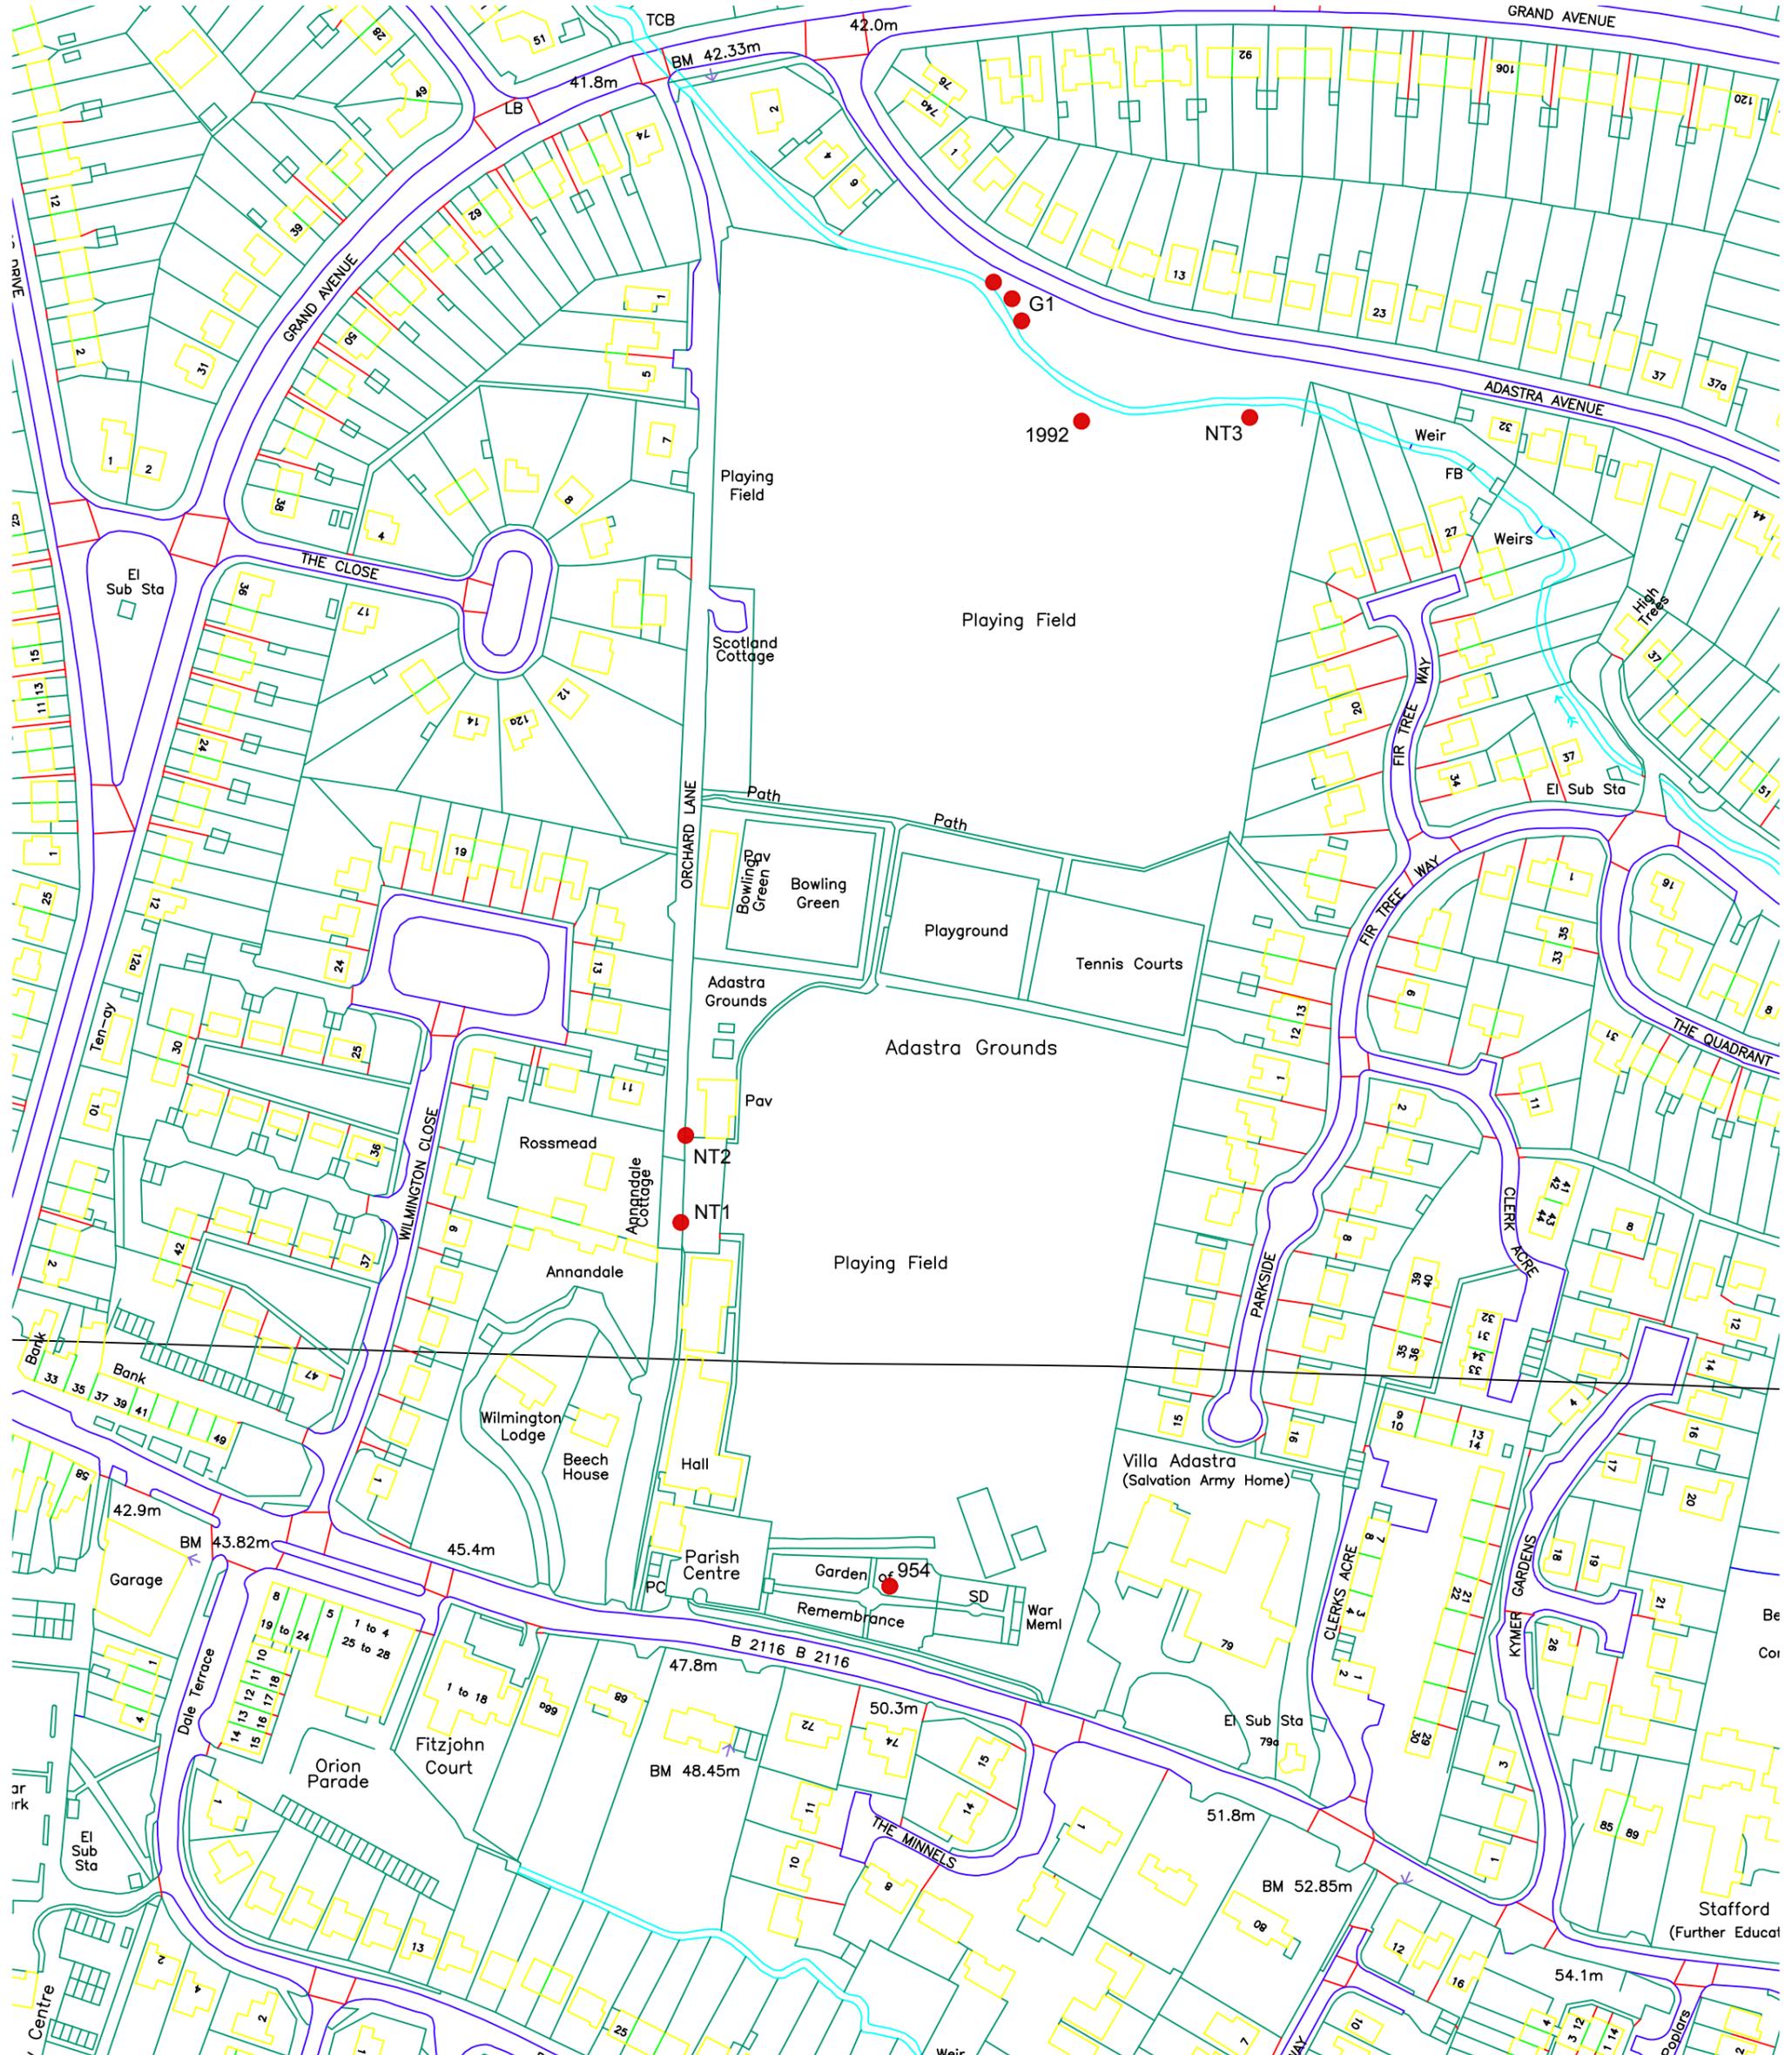
Drawing title: Tree Location Plan

Tree Number	Species	Height	Age Class	Physical condition	Structural condition	Defect Notes	Action Required	Location notes	Frequency of Use	Works Priority	Date of Inspection
954	Silver birch, (Betula pendula)	16	Mature	Poor	Poor	Standing dead tree	Fell	Adastra Park	High	Amber	4th July 2025
NT1	Lime, (Tilia spp.)	18	Mature	Fair	Fair	Dead wood in crown	Remove dead wood	Adastra Park	High	Green	4th July 2025
NT2	Scots pine, (Pinus sylvestris)	20	Mature	Fair	Poor	Basal decay	Fell	Adastra Park	High	Amber	4th July 2025
G1	Ash, Fraxinus excelsior)	18 - 22	Mature	Poor	Poor	Ash dieback affecting group of trees	Fell all ash with more than 20% crown dieback	Adastra Park	High	Green	4th July 2025
1992	Weeping willow, (Salix babylonica)	15	Mature	Poor	Poor	Standing dead tree	Fell	Adastra Park	High	Amber	4th July 2025
NT3	Ash, Fraxinus excelsior)	14	Semi mature	Poor	Poor	Standing dead tree	Fell	Adastra Park	High	Amber	4th July 2025

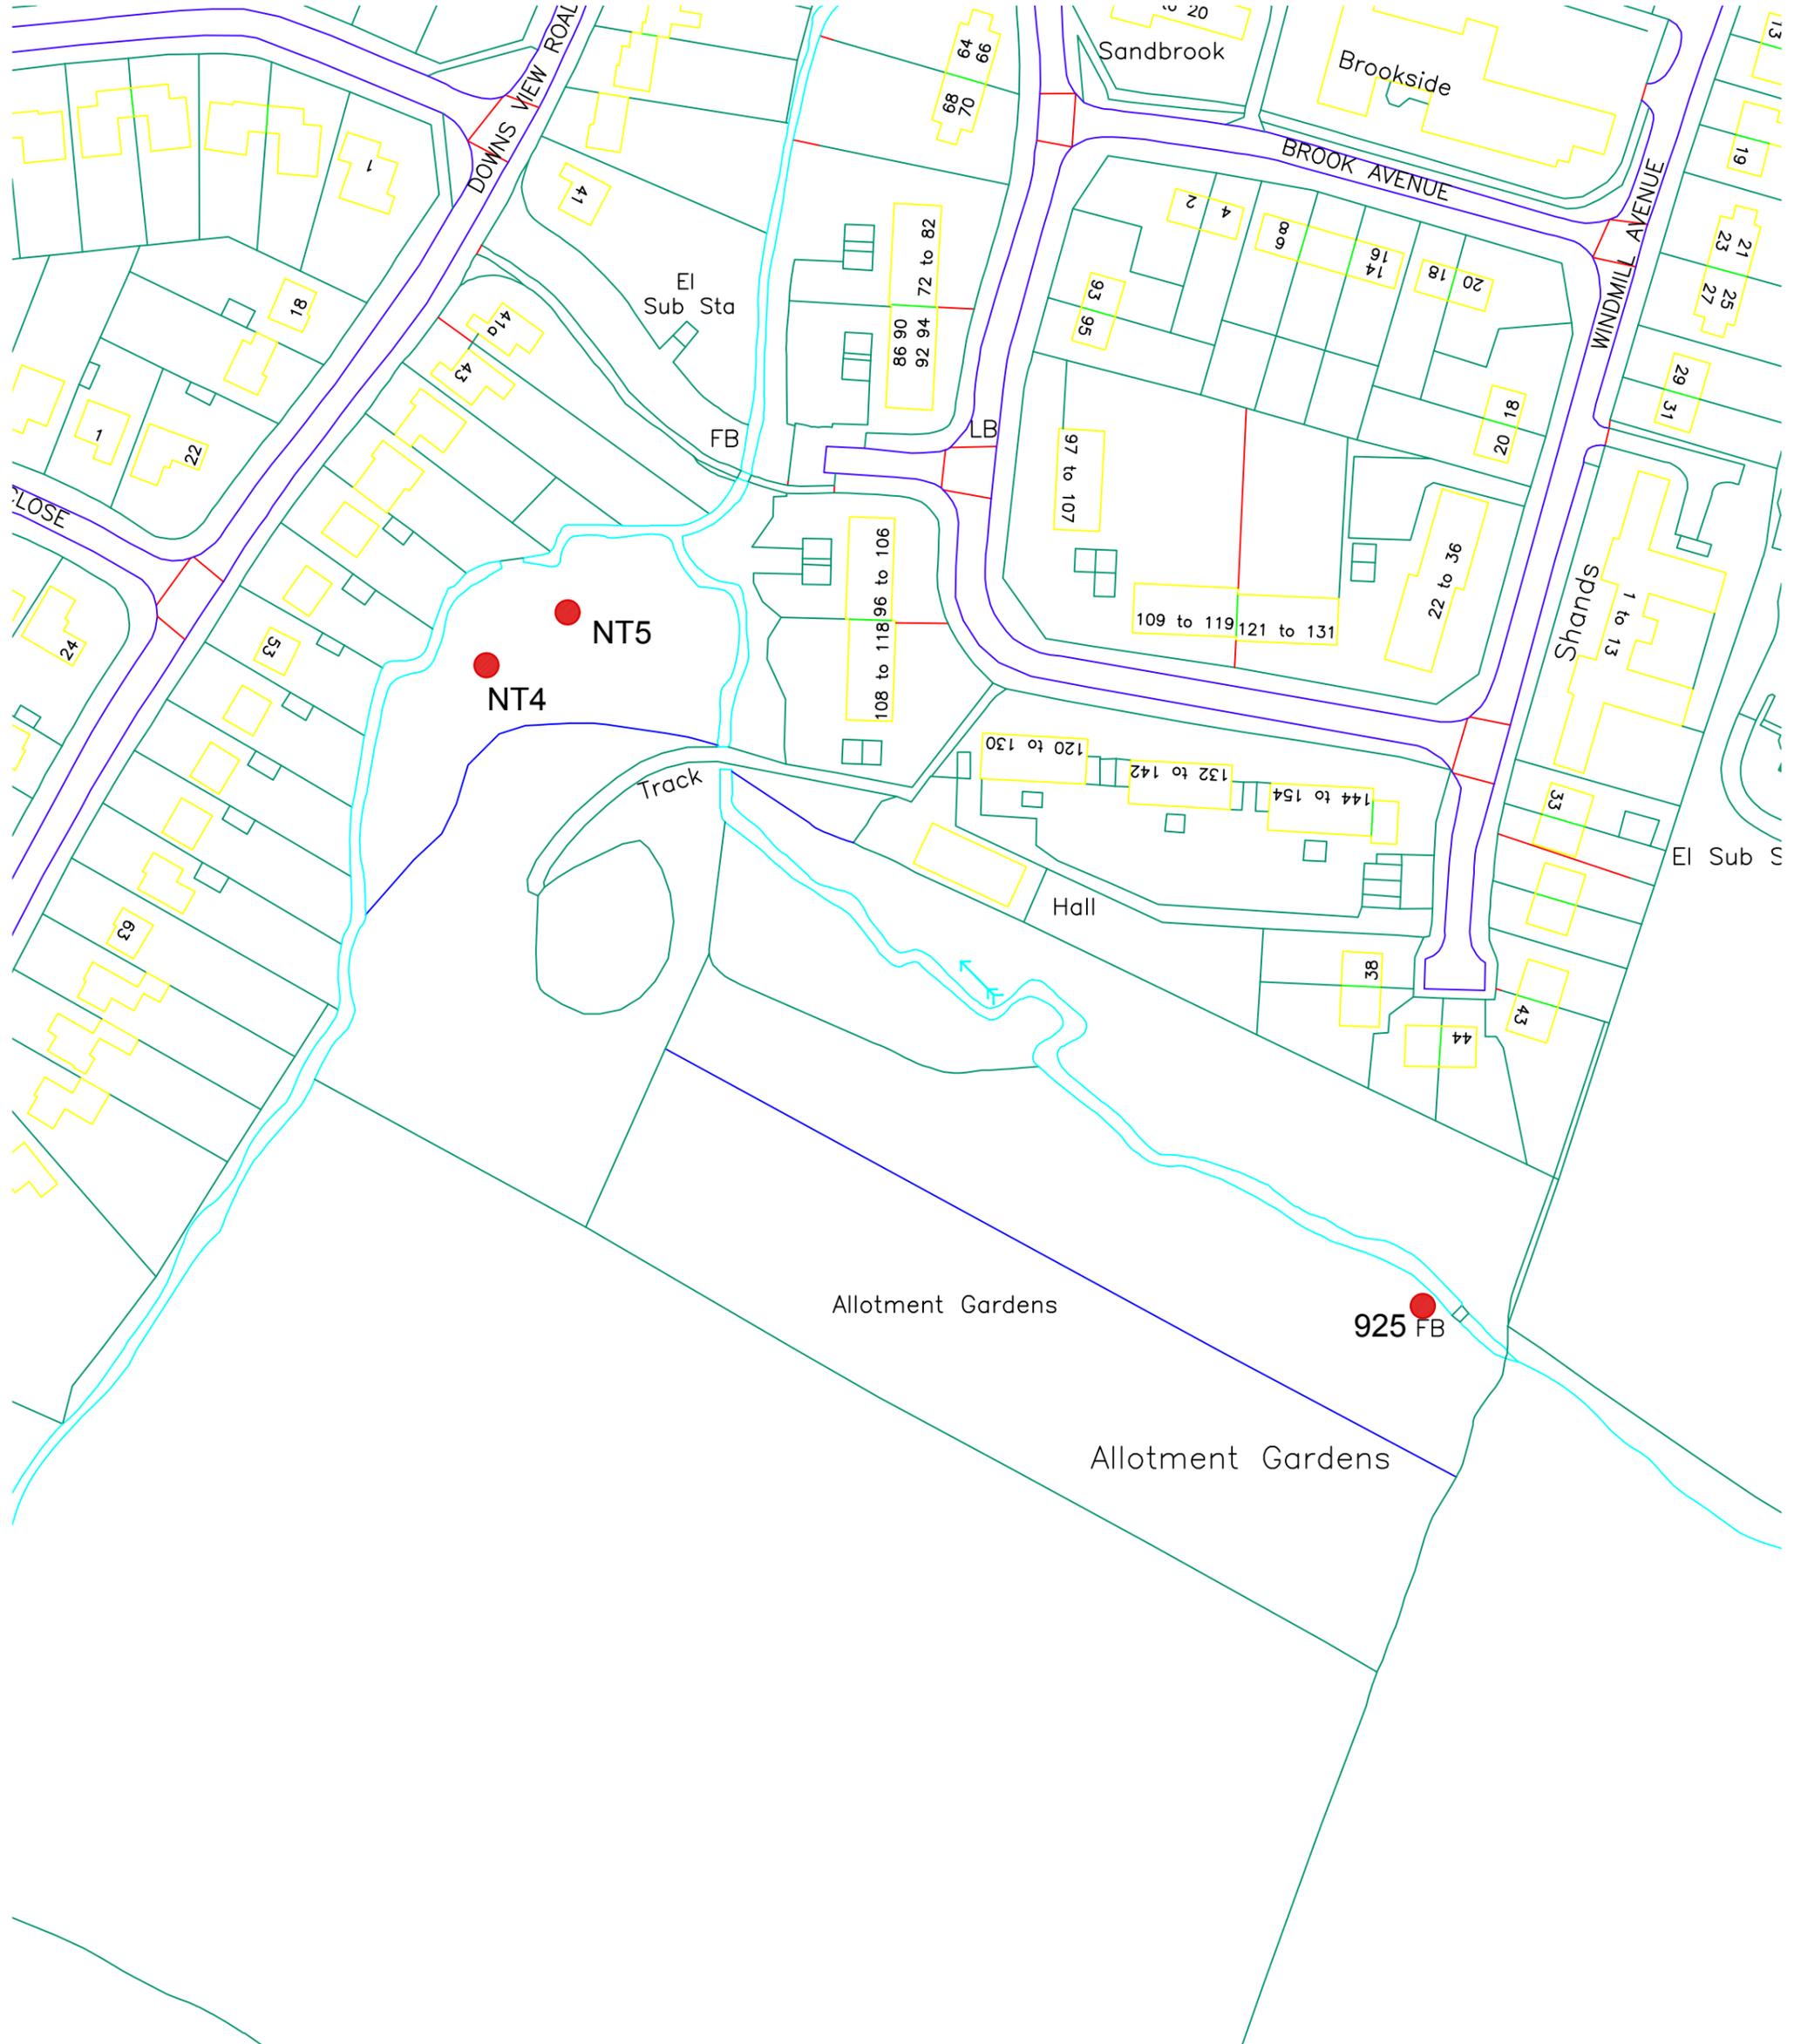
Drawing title: Tree Location Plan

NT4	Ash, Fraxinus excelsior)	18	Mature	Poor	Poor	Dying tree	Fell	Parklands Copse	Moderate	Green	4th July 2025
NT5	Unidentified	17	Mature	Poor	Poor	Standing dead tree	Fell	Parklands Copse	Moderate	Amber	4th July 2025
955	Hawthorn, (Crataegus monogyna)	6	Mature	Fair	Poor	Stem decay	Fell	Parklands Copse	Moderate	Amber	4th July 2025
