# ADASTRA PARK DRAINAGE IMPROVEMENTS- GENERAL ARRANGEMENT

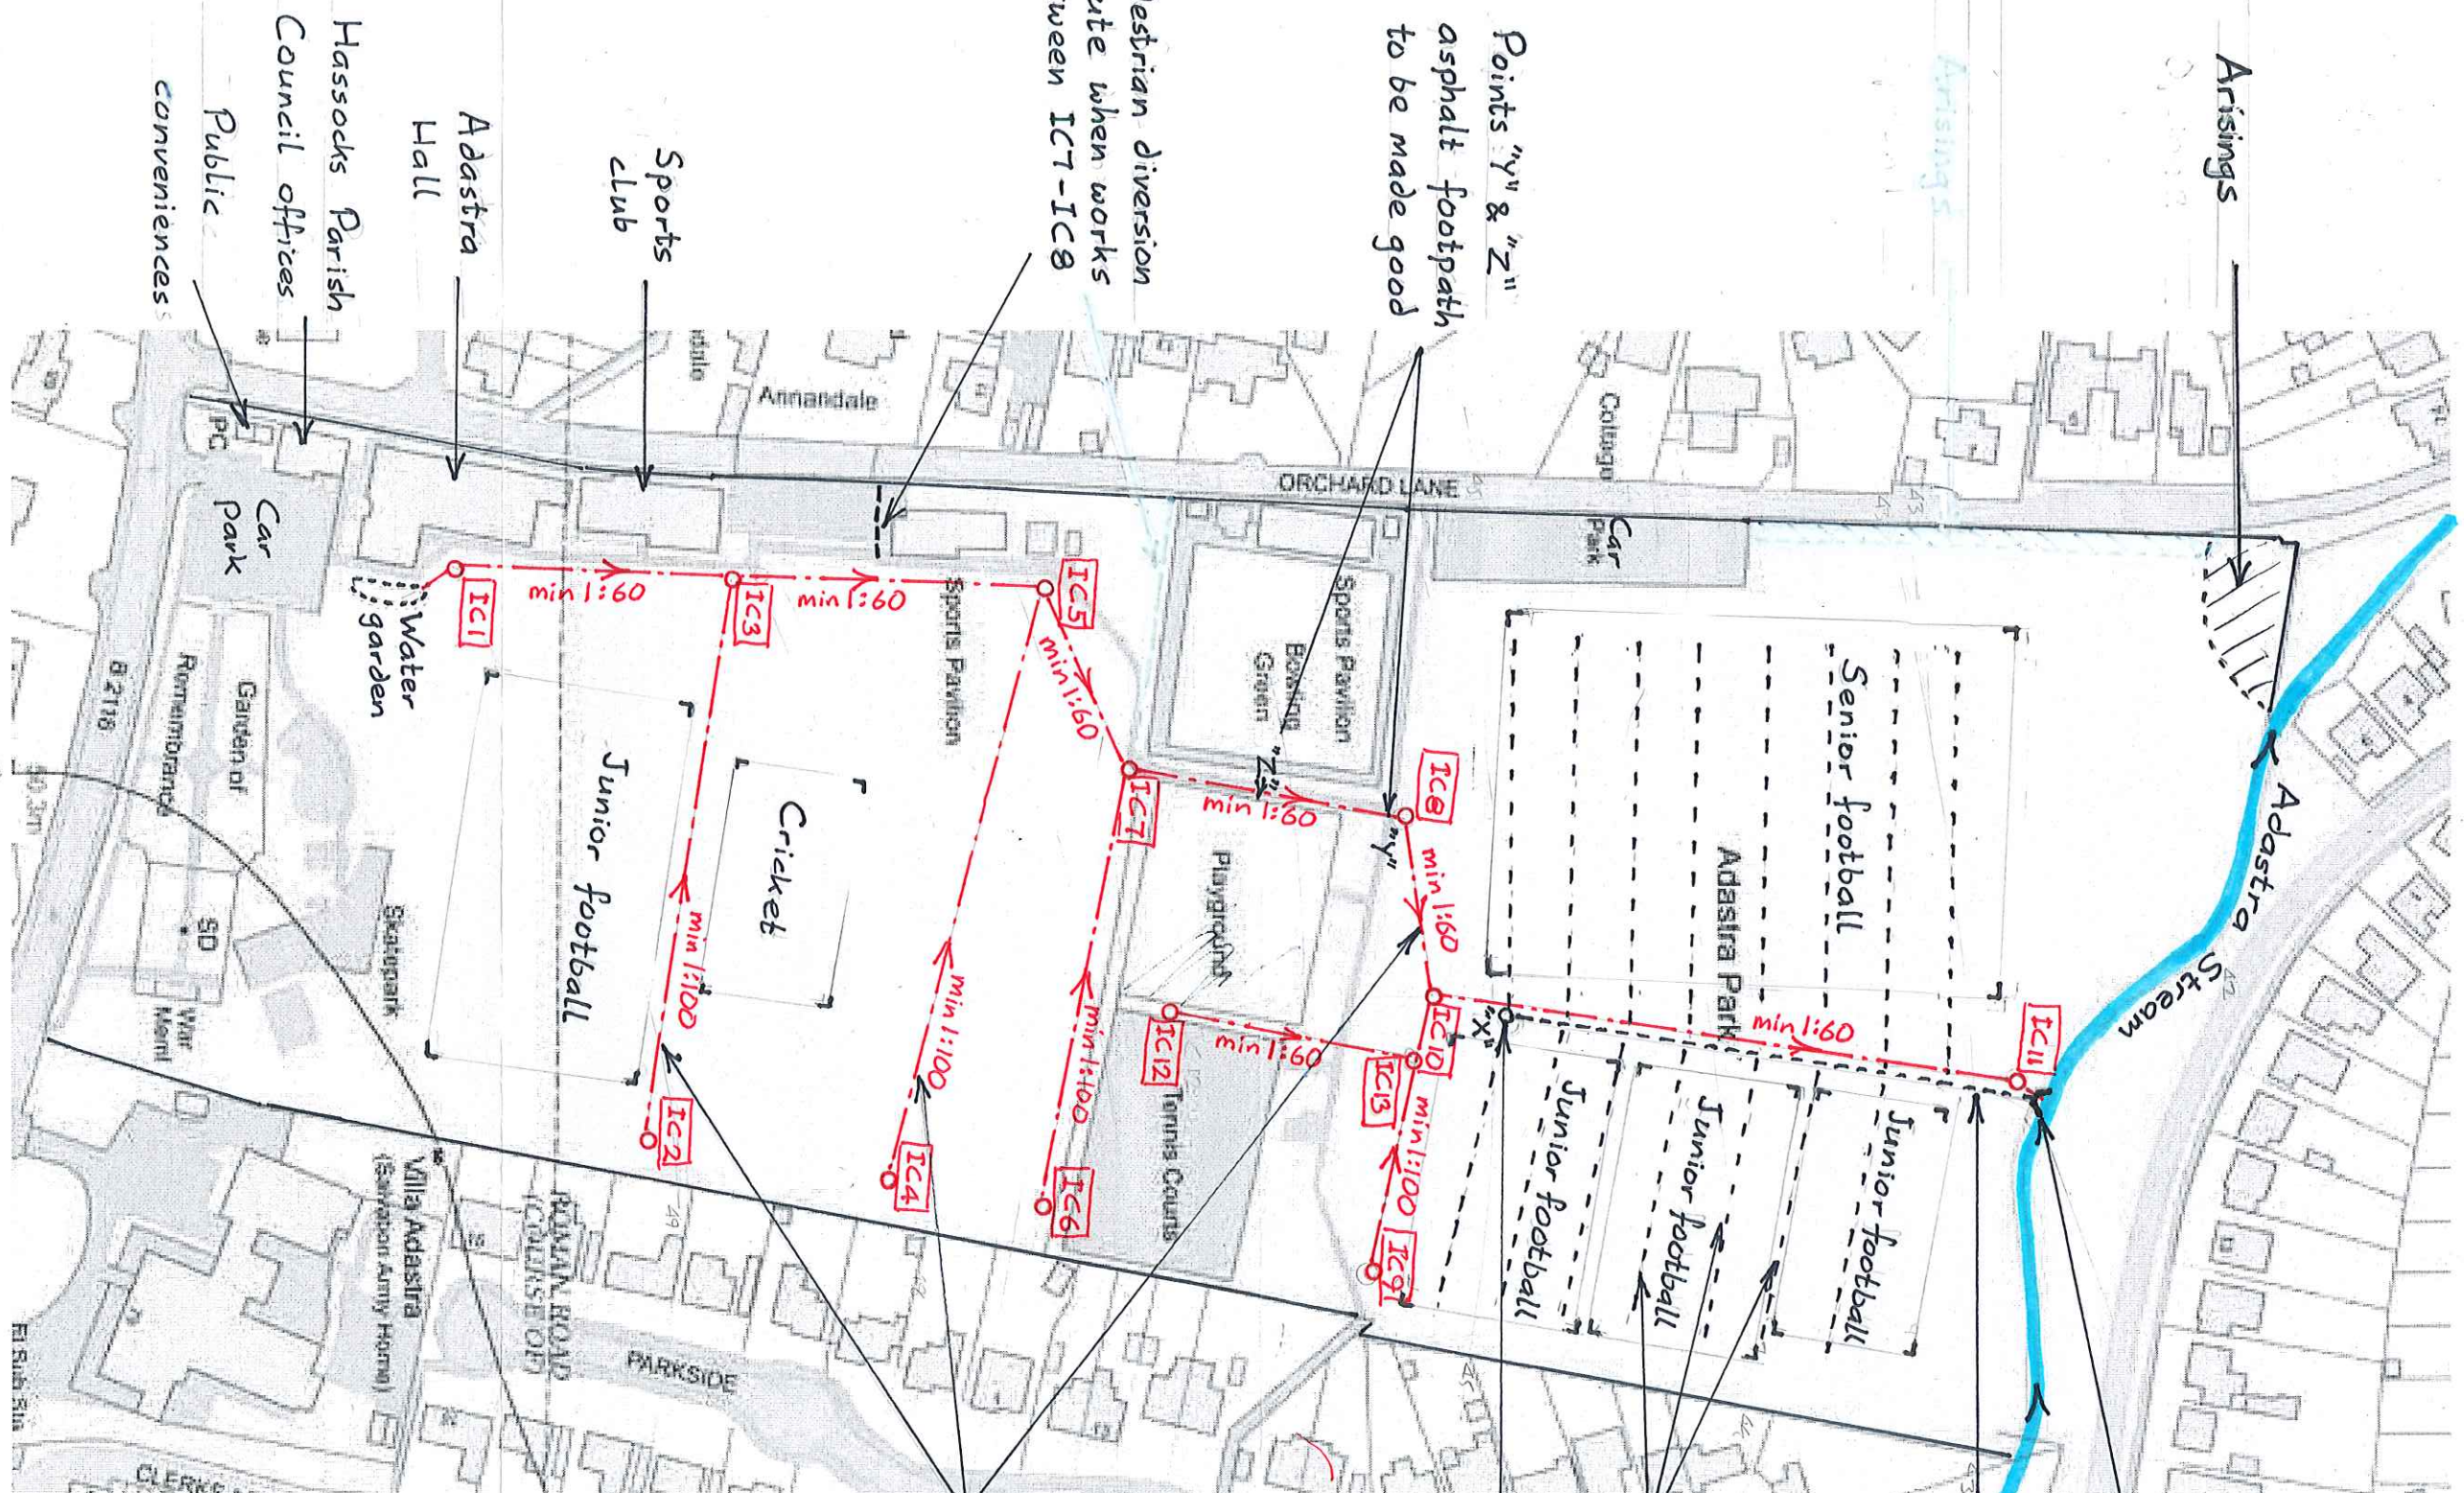
Existing headwall

Approx line of existing main carrier drain from "Google Earth" aerial view. Believed to be plastic pipe (150 dia?) approx 400-500 to invert level.

Indicative line of existing lateral drain runs (c2014) from "Google Earth" aerial views, (80 dia?) Point "X" to be located.

Route of main carrier drain connecting inspection chambers IC1 - IC11

Pedestrian diversion route when works between IC7-IC8

Points "Y" & "Z" asphalt footpath to be made good
