# BUILDING SURVEY

NOVEMBER 2024

- 2.1.1 XXXXXXXX comprises a large detached two storey house, constructed in the 1930s. Originally, the property was constructed to a high standard for the period, using similar quality materials and workmanship. The Vendor has owned the property for 47 years, during which time there have been minimal major alteration works. They did, however, have a swimming pool installed and the tennis court restored shortly after taking occupation. Further alterations include the construction of workshop outbuildings in the northwest corner of the garden and replacement of the boiler many years ago.

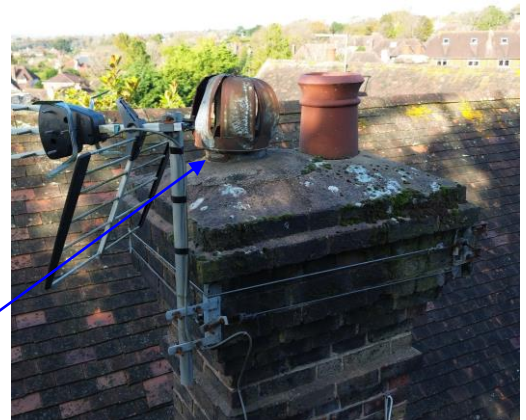
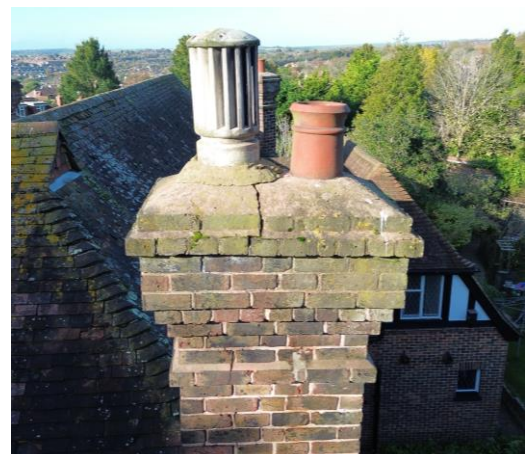
3.1.10 Lead flashings around the base of most chimney stacks are aged and weathered, albeit they remain in satisfactory and watertight condition. Allowances for the replacement of lead flashings should be made for the medium to long term. It is important to ensure that the back valleys to these chimneys are regularly checked and

cleared. Failure to ensure this can result in blockages and water ingress. Several of these are currently blocked and should therefore be unblocked now and regularly thereafter.

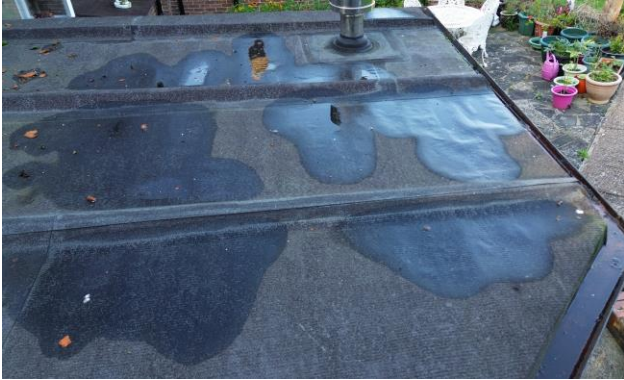
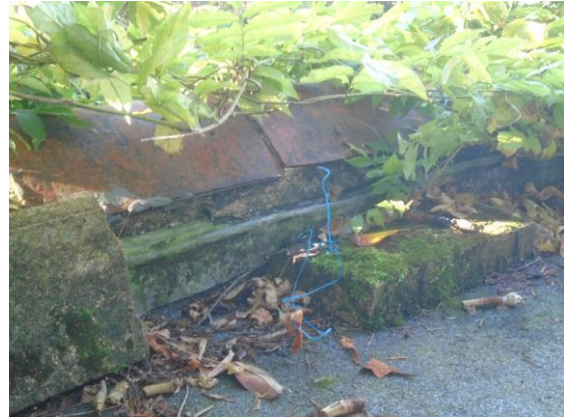
- 3.3.6 There is a crown roof over the entrance porch, consisting of a central mineral felt covered flat roof with a pitched profile surround. The felt is worn but remains serviceable. Allowances for the replacement of this should be made for the medium term. Mortar bedding to the perimeter ridge tiles has deteriorated, as have the lead flashings. We recommend that the ridge tiles are re-bedded over new lead flashings in the short term. Several damaged plain tiles to the pitched surrounds should be replaced as part of these works.

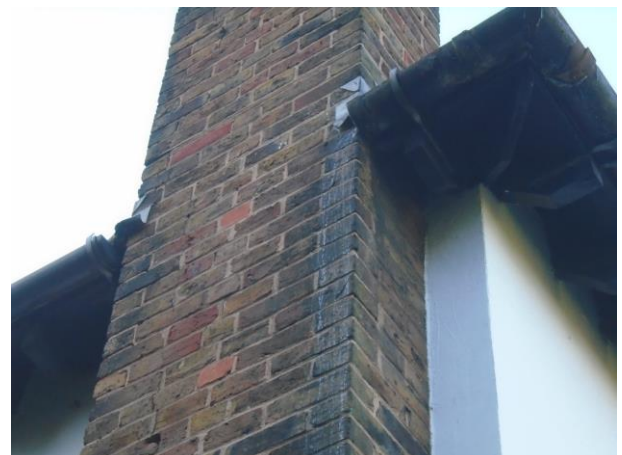
- 3.6.3 Rainwater goods require regular ongoing maintenance and clearance to prevent blockages and overflowing rainwater. It is recommended that these maintenance works are carried out at least every 6 months.

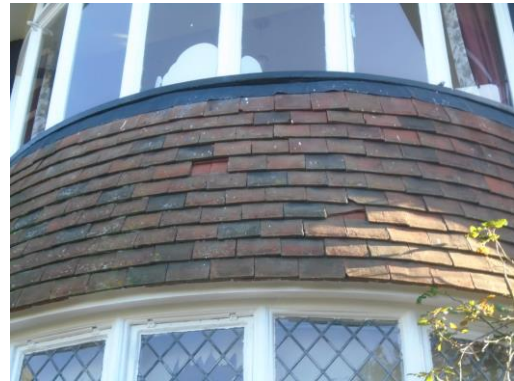
3.7.7 Most of the plain clay tiles to the wall cladding is in a good condition, although there are a handful of broken tiles to the west bay window. Defective tiles should be replaced in the short term.

3.7.8 There is a large wisteria plant growing across the porch projection. These plants grow very quickly and can cause damage to building fabric. This has not caused any obvious damage to the building to date, although this should be monitored. If problems arise, then the plant should be removed.

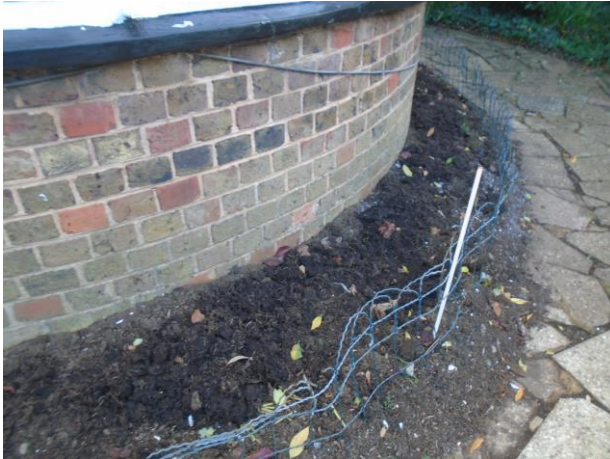
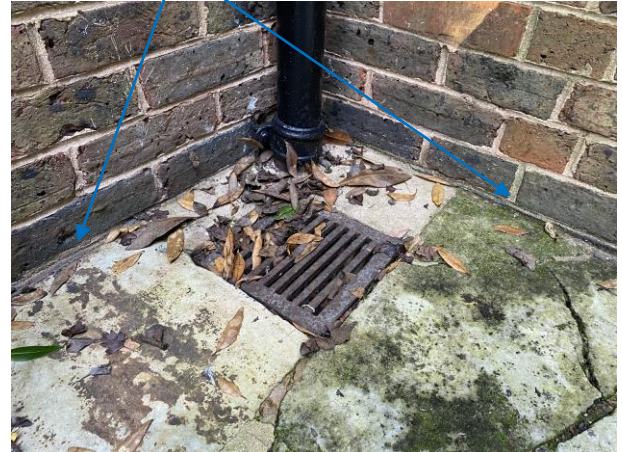
- 3.11.2 The property has a double-layer slate damp proof course with bitumen felt damp proof courses in areas. Most of the DPCs are at the correct, although ground levels have been raised to the bay window on the front of the south wing and to parts of the east elevation. This has bridged the DPC which can lead to rising damp. No signs of this were recorded to the drawing room internally, although we did find evidence of low-level damp to the east wall of the library. We suspect that the ground levels bridging the damp proof course have caused this. Ground levels to the bay window and east elevation should be reduced in height to provide a clearance of at least 150mm below the DPC.

- 3.11.3 Please note that bitumen felt damp proof courses are known to contain asbestos. The risk of exposure to such a material is low due to its mostly concealed location. Nevertheless, testing for asbestos must be carried out prior to any intrusive works.

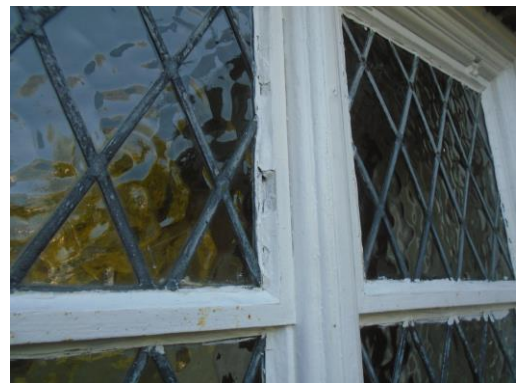
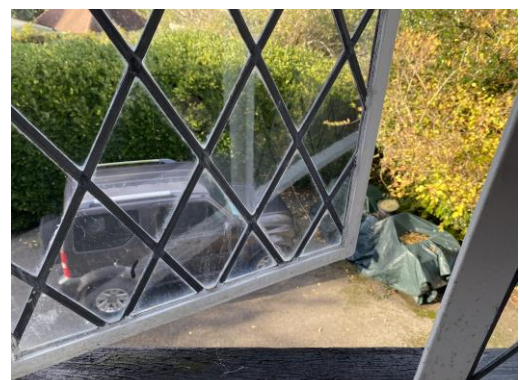
- 3.13.1 The windows are primarily single-glazed steel Crittall type with leaded lights and plain glazing, along with some timber-framed windows in certain areas. The majority of the windows are inoperable due to seized ironmongery and being painted shut. Several are stuck in an open position. Additionally, the glazing has bowed and cracked in multiple locations, and the putty is damaged. The single glazing creates a security weak point, and the non-safety glass can easily be damaged which can lead to accidental injury. Another concern is the poor thermal performance of the windows, as well as inadequate means of escape in the event of a fire. We suggest that the windows are replaced with new double glazed uPVC casement windows with trickle vents in the short term. We counted 96 windows.

- 3.13.2 The stained-glass oriel window to the rear is in a good condition for its age and is an attractive historic feature.

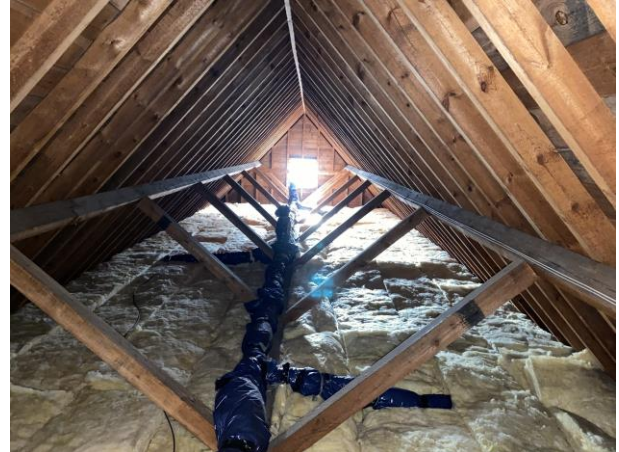
4.1.2 The roof is a traditional timber framed purlin structure with 100mm x 50mm timber rafters that bear off the external walls and rise to a central ridge board. Horizontal timber purlins support the rafters, and these are supported by timber struts bearing off internal loadbearing walls. Timber close boarding is laid above the rafters, and we observed a sarking felt underlay above the close boarding. The roof is well braced, and there is no evidence of any distortion to the frames.

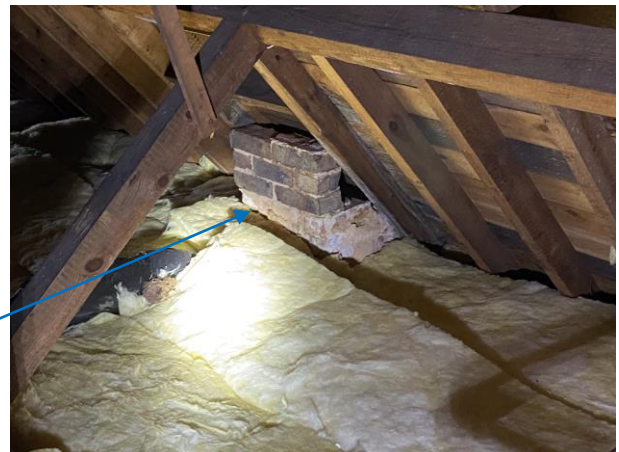
4.1.7 The remains of an original chimney stack which was taken down are visible in the roof space, beneath the rear roof pitch.

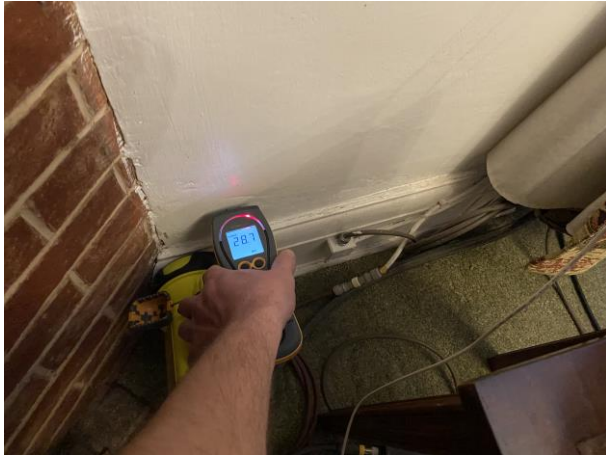
4.5.4 For dampness to penetrate the internal leaf of a cavity wall, the cavity must either be blocked or insulated. Following external repairs, we recommend that several bricks are removed from the areas where damp is

present, and the cavity cleared of any blockages or saturated insulation. Any removed insulation should be replaced.

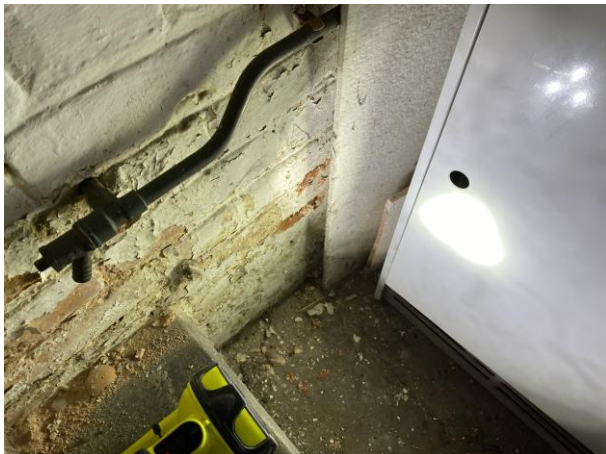
- 4.5.5 Low-level walls to the boiler room are suffering from dampness, which is expected given that this is at a lower height to the main house. Due to the use of this room, we do not consider damp treatment works necessary, although you may decide otherwise.

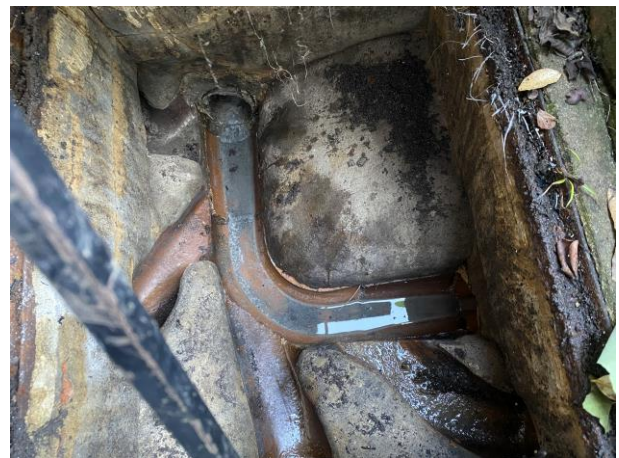
5.5.4 All chambers are of conventional design and construction with clay pipework. Several of the chambers were holding a small volume of water at the time of our visit which may indicate a blockage. Visible pipework was seen to be in satisfactory condition.

5.5.5 We always recommend that a CCTV drainage survey is carried out to fully establish the condition of underground drainage before committing to a purchase, and this would be prudent here. Any blockages should be cleared at this time.

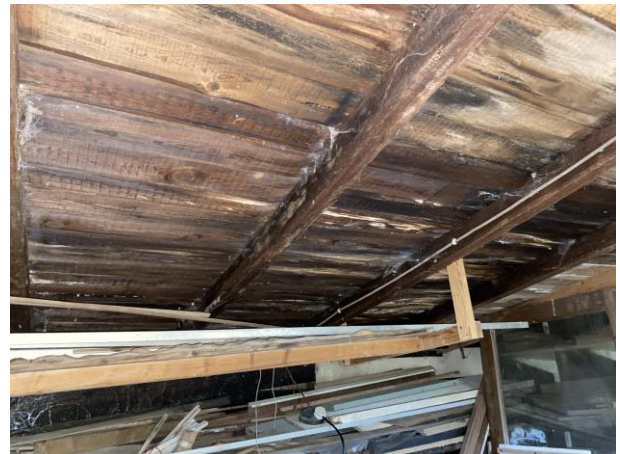
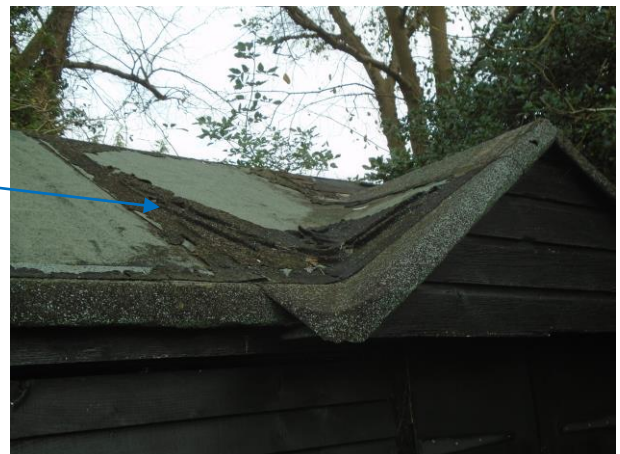
- 6.1.4 The east shed and both west sheds are in poor condition with perished roof coverings that are leaking internally. This has resulted in severe wet rot decay to the roof and wall structures. Consequently, the sheds are leaning. We recommend that all three of these sheds are replaced in the short term. The greenhouse should also be replaced as part of these works due to widespread broken glazing.

- 6.1.5 The pool shed is in a satisfactory condition for now, although allowances for a new roof covering should be considered for the medium term.
- 6.1.6 The roof covering to the north shed has perished and is leaking which has led to a rotten timber roof structure. The roof to this shed should be replaced in the short term.

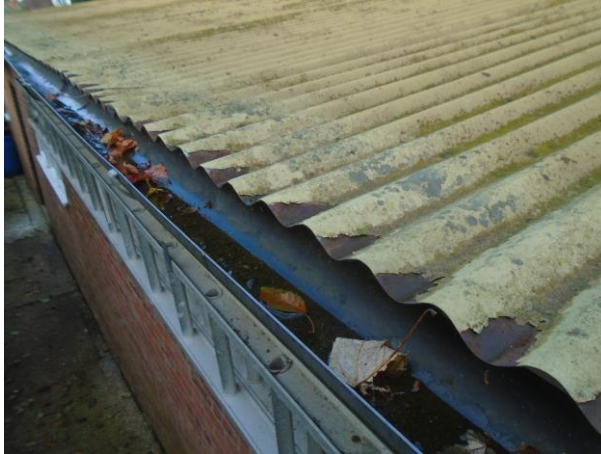
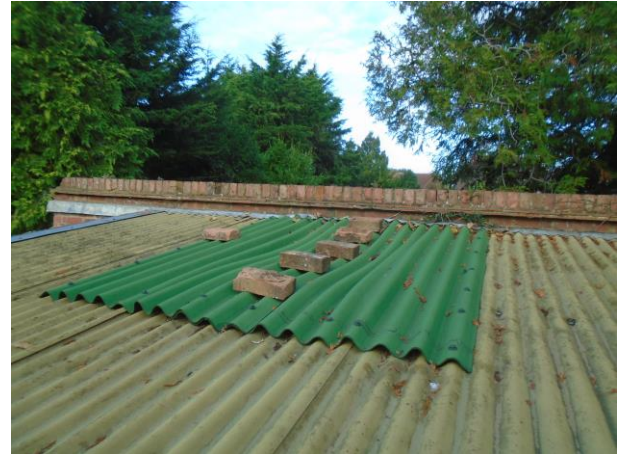
- 6.1.7 There is a brick-built workshop in the northwest corner of the grounds which is split into two sections. Structurally, the workshop remains in good condition, although the roof sheets are suffering from cut edge corrosion and there are compromised roof sheets on the lower roof to the

west workshop. Attempts to repair these roof sheets has been made by overlaying them with a different type of roof sheet. This has been unsuccessful as we observed ongoing leaks internally. We suspect that the flashings are also leaking where they meet the brickwork parapet wall, due to staining visible on the internal brickwork. Corroded roof sheets should be treated with proprietary metal coatings, the defective roof sheets replaced, and the lead flashings replaced in the short term. Gutters must also be repaired as these are leaking in several locations.

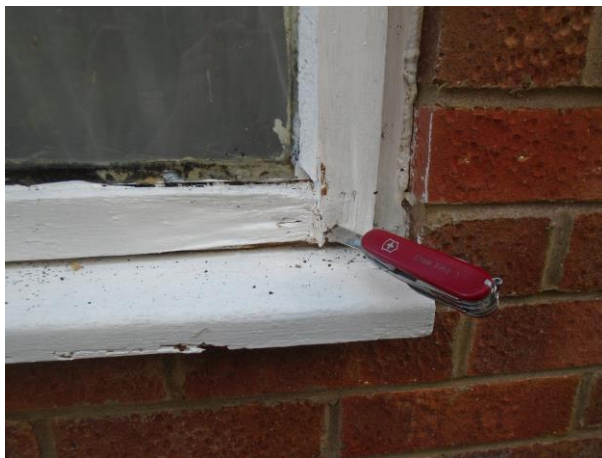
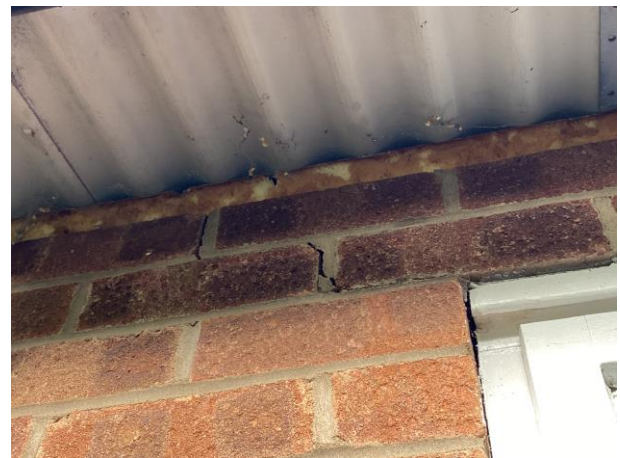
- 6.1.8 Timber windows to the workshop are also rotten and we suspect that a lintel has failed over one of the windows as evidenced by cracking. Rotten timber should be cut out and replaced and a new lintel installed.

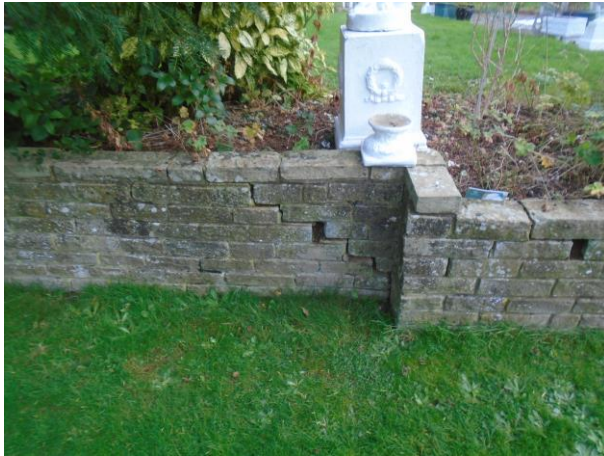
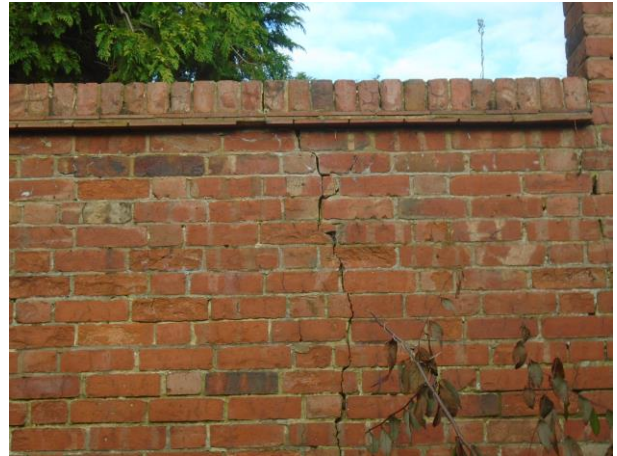
- 6.2.3 There is a low-level block retaining wall towards the front of the rear garden which is cracked and leaning inwards. We recommend that this is replaced in the short term.

- 6.2.4 There is a tall brick wall forming the west boundary. Adjacent to the workshop, there is a long vertical crack through the wall. We recommend that this is stitch repaired using Helibars in the short term.

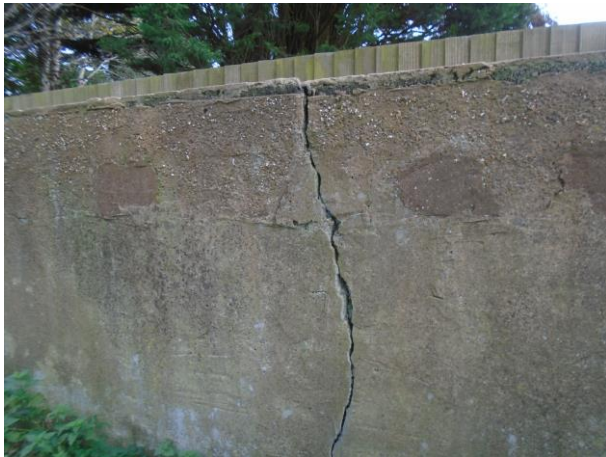
- 6.2.10 There is a rendered brick boundary wall adjacent to the secondary site entrance gate which has a large structural crack, making the wall unstable. We strongly recommend that this wall is replaced promptly.

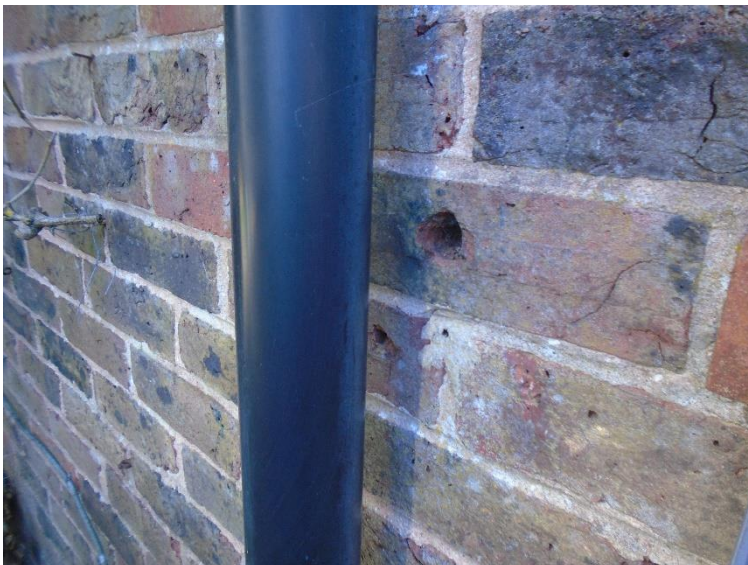
15.

Fixing holes to the southwest corner of the south wing.

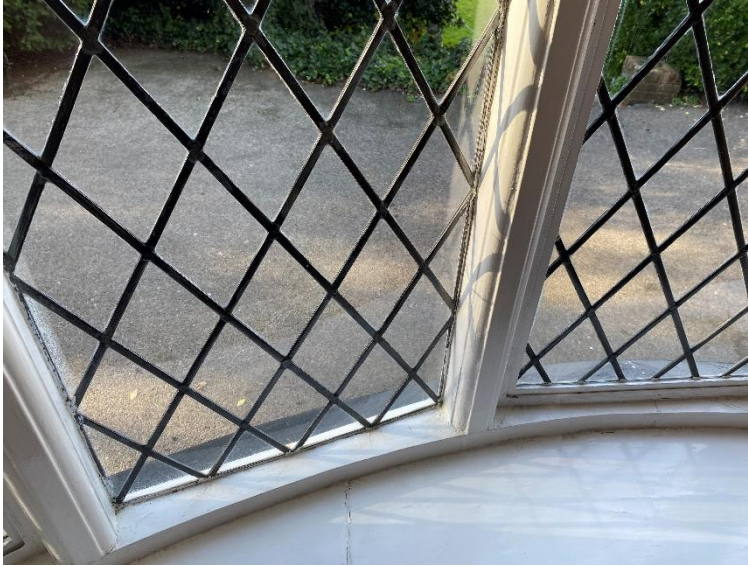
22.

Bowed glazing to the dining room.

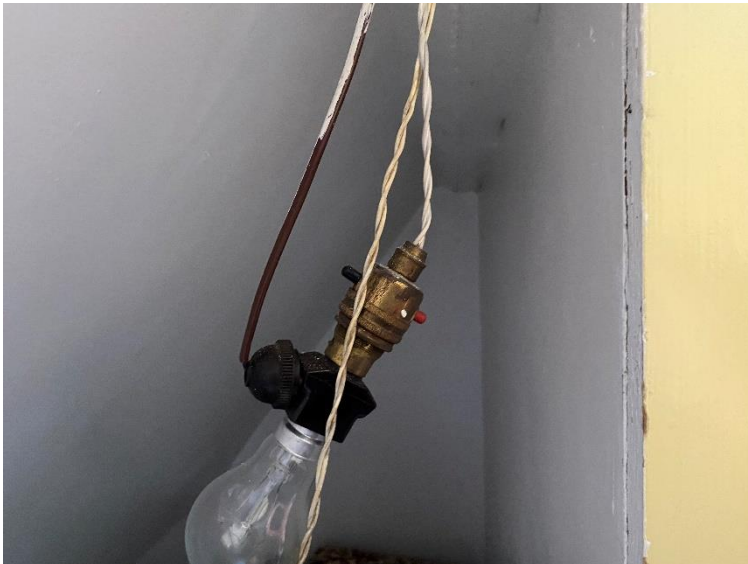
23.

Old lighting cables.

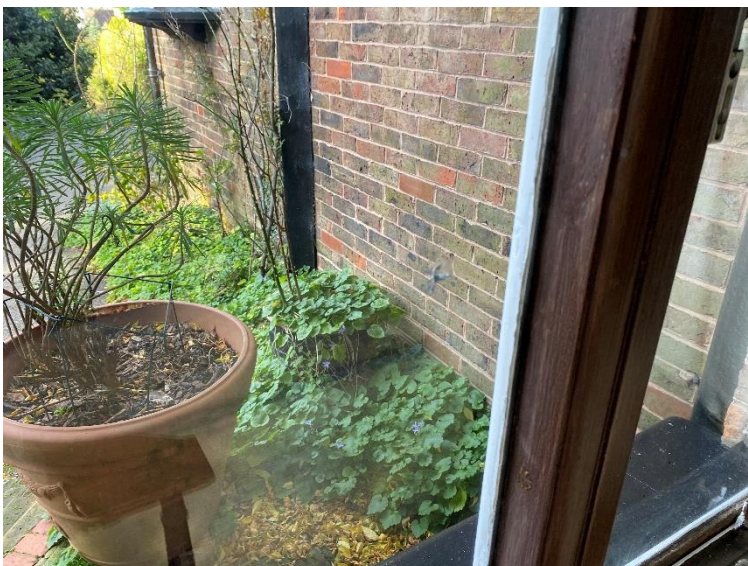
24.

Chipped glazing to the entrance hallway.

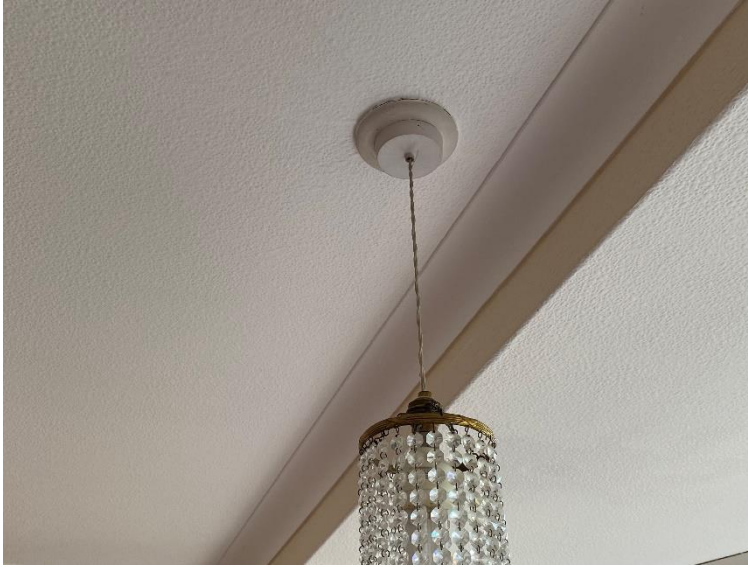
25.

Old lighting cables.

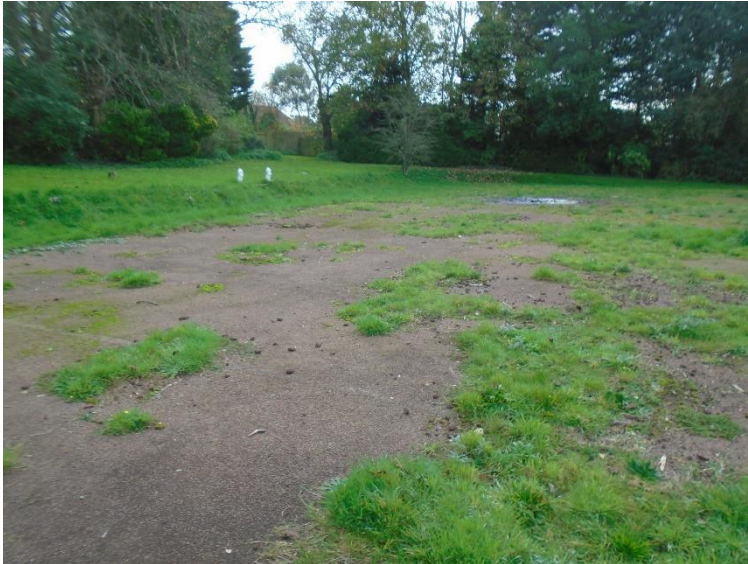
29.

- 6.2.8 Tarmacadam to the old tennis court is broken up and uneven in large areas and has extensive vegetation growth. Wholesale replacement of this hardstanding is necessary in order to create a tennis court. The new surfacing will need to be laid over a weed membrane (terram). This is something you should budget for if you intend on restoring the tennis court.

Tennis court.
